Appendix M

Detailed Seaside and Landside Investigation
of the Low Battery Seawall
Photographs, Field Notes, and Sketches

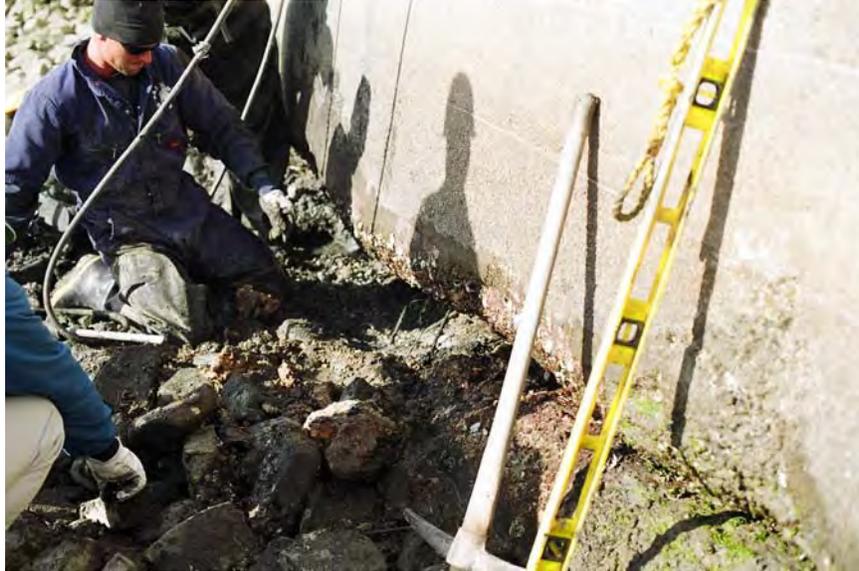
Detailed Seaside Investigation of the Low Battery Seawall
Station 9+73 (84 Murray Boulevard)
In the zone below the horizontal crack and above the mud line,
the concrete was generally of poor quality.

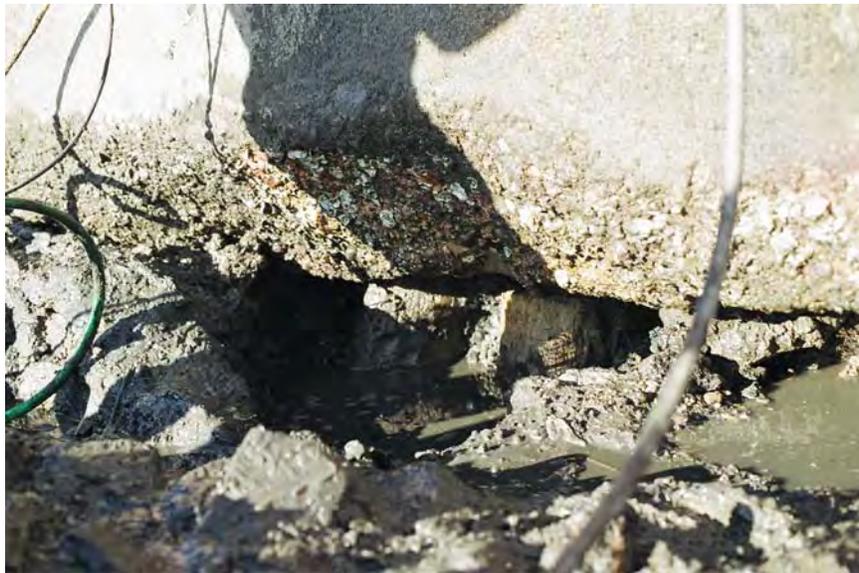
Detailed Seaside Investigation of the Low Battery Seawall
Station 9+73 (84 Murray Boulevard)
In this zone, the concrete was soft, deeply fissured, broken,
and easily removed with pneumatic hand tools.

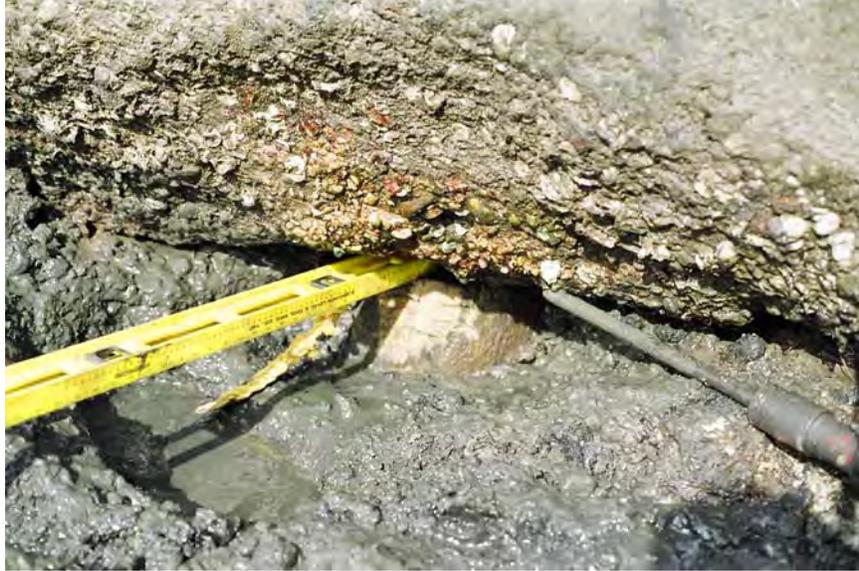
Detailed Seaside Investigation of the Low Battery Seawall
Station 9+73 (84 Murray Boulevard)
Note the approximately one inch gap between the top of the pile
and the underside of the concrete seawall.

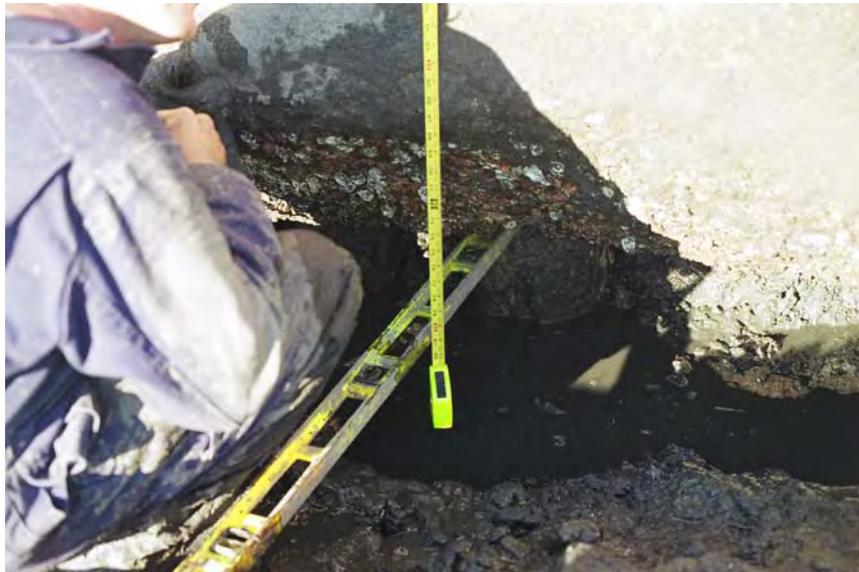
Detailed Seaside Investigation of the Low Battery Seawall
Station 9+73 (84 Murray Boulevard)
The top of the pile is approximately 82 inches (6'-10") below the seawall coping..

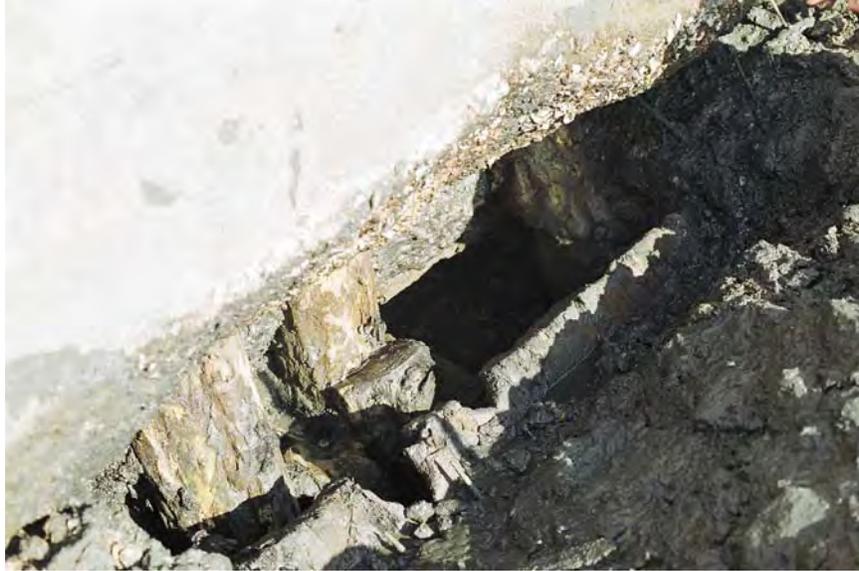
Detailed Seaside Investigation of the Low Battery Seawall
Station 9+73 (84 Murray Boulevard)
Four batter piles, one vertical pile, and the top portions of the
timber sheet piles and concrete veil were exposed at the
opening of the cavity.

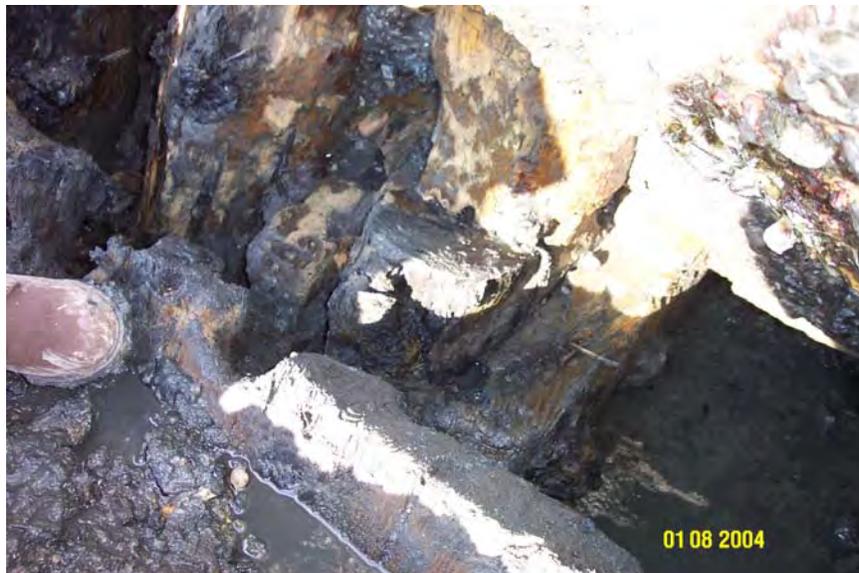
Detailed Seaside Investigation of the Low Battery Seawall
Station 9+73 (84 Murray Boulevard)
A pair of exposed 5" wide x 12" deep timbers extended approximately
perpendicular to the face of the seawall. The timbers were bolted
to the vertical pile and its adjacent seaward batter pile.

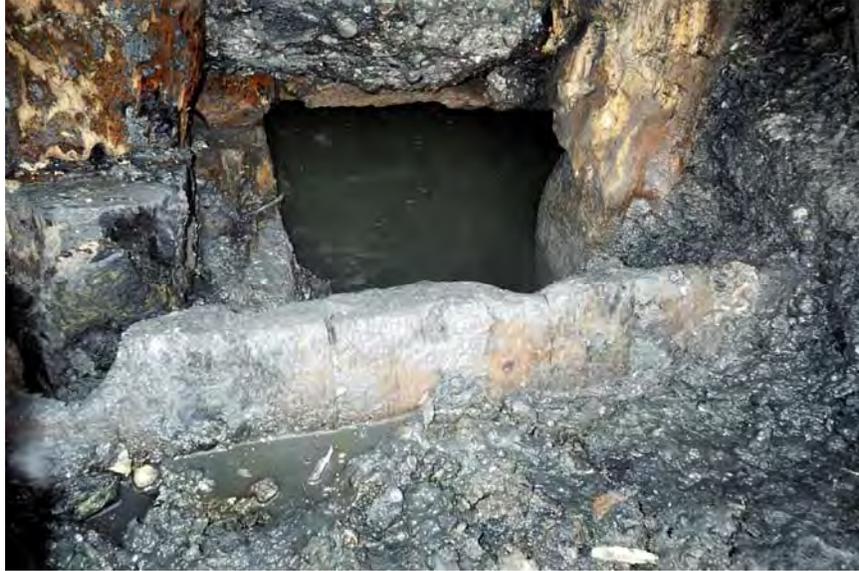
Inconsistent with the archival sketch on page 1 of Appendix F, the seaward edge of the timber deck platform terminated approximately 2 ½ feet landward from the seaward face of the seawall.

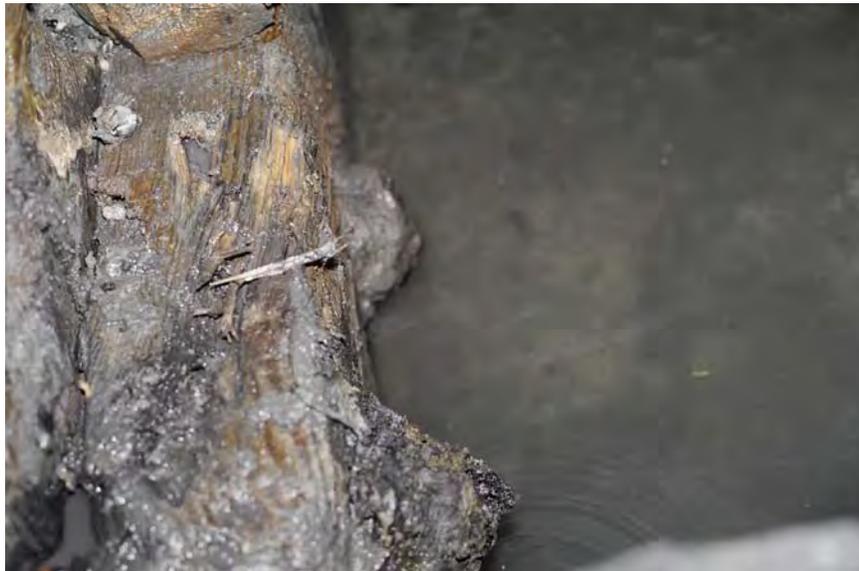
The steel bolts, nuts, washers used in the connection of the 5" x 12" timber framing to the support piles were severely corroded. The ends of the bolted connections were heavily encrusted with a ferrous compound.

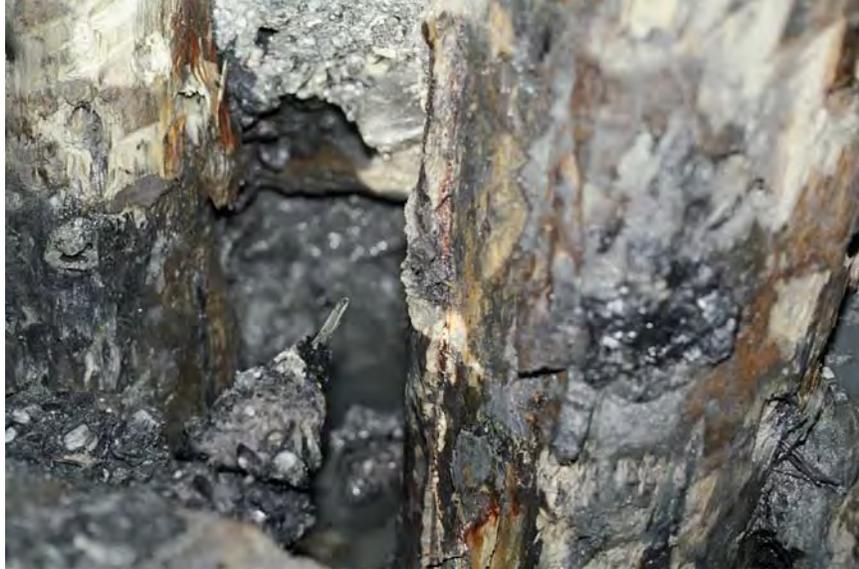
Detailed Seaside Investigation of the Low Battery Seawall
Station 9+73 (84 Murray Boulevard)
Considering the deep crevices in this localized area of the seaward face
of the concrete seawall, there was remarkably little marine
borer damage to these five exposed timber piles.

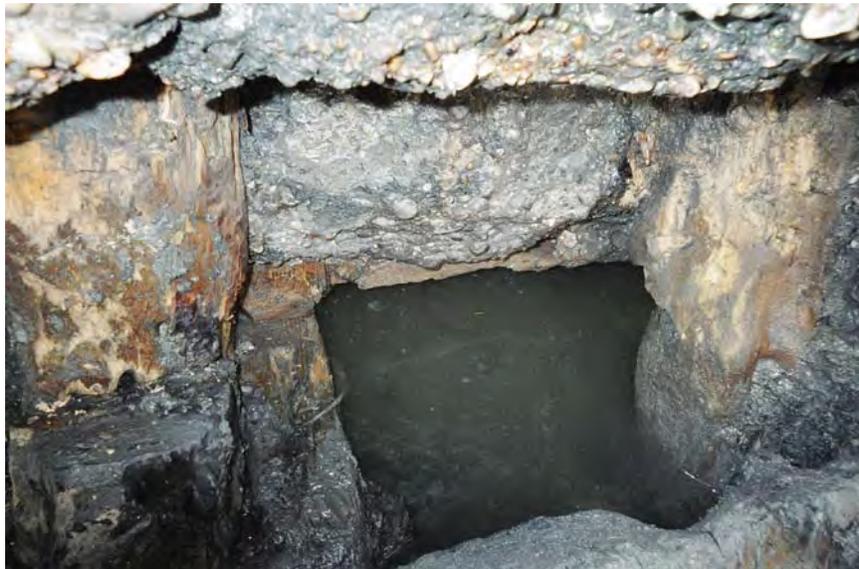
Detailed Seaside Investigation of the Low Battery Seawall
Station 9+73 (84 Murray Boulevard)
The ceiling of the cavity sloped irregularly downward from the seaward
opening. Further towards the interior of the seawall and above the
ceiling of the cavity, the concrete was substantially harder.

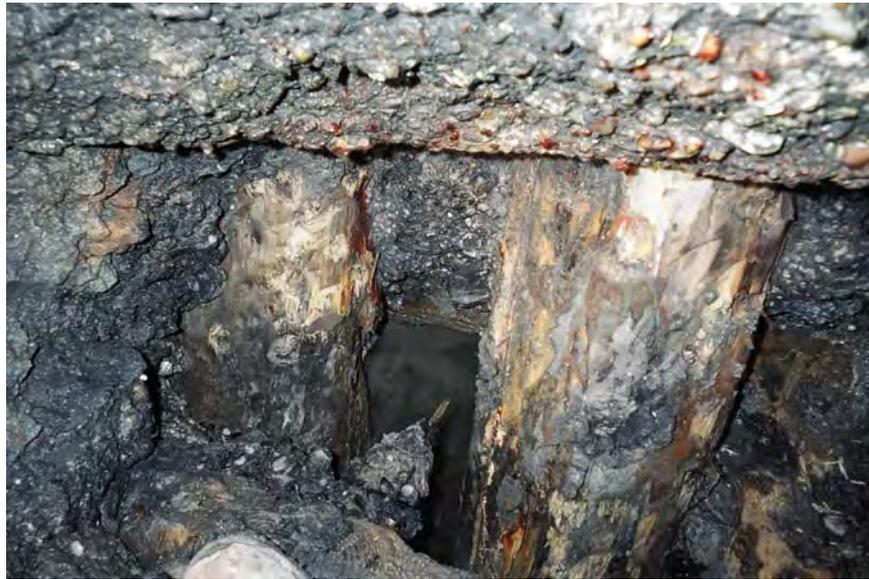
Inconsistent with the archival sketch on page 1 of Appendix F, the seaward edge of the timber deck platform terminated approximately 2 ½ feet landward from the seaward face of the seawall. The archival sketch clearly indicates that the timber deck was to extend to the seaward face of the seawall to provide support for the full width of the base of the cast-in-place concrete seawall.

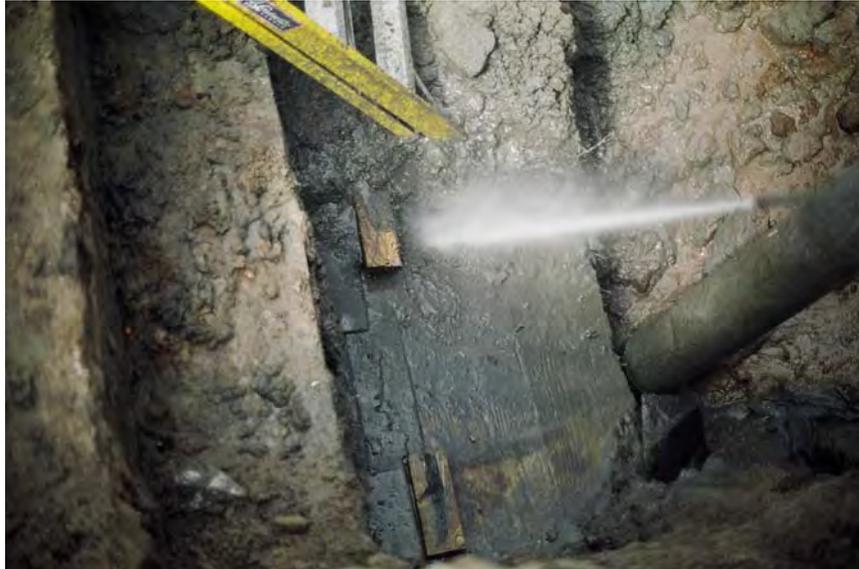
The inspection revealed that the seawall construction was generally consistent with the archive drawings. The measured step down pattern on the landside closely correlated with the step down pattern indicated in the archive drawings.

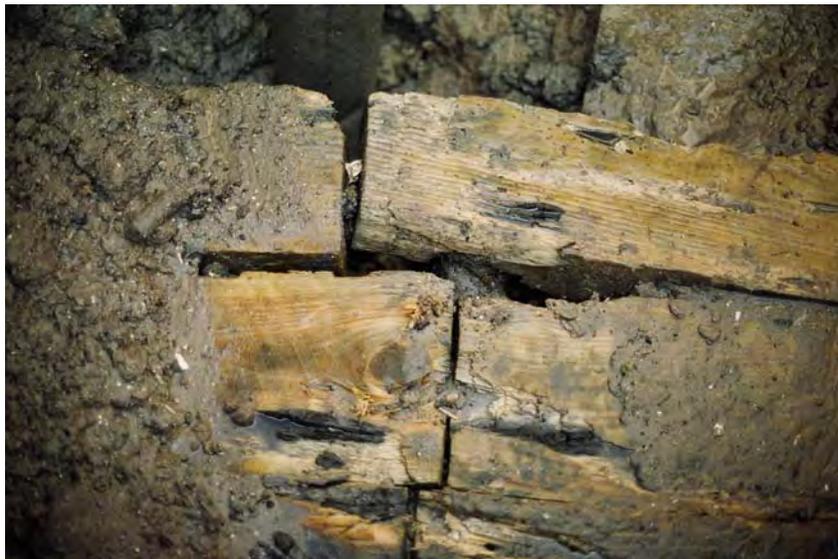
Detailed Landside Investigation of the Low Battery Seawall
Station 9+73 (84 Murray Boulevard)
The inspection revealed that the seawall construction was generally
consistent with the archive drawings.

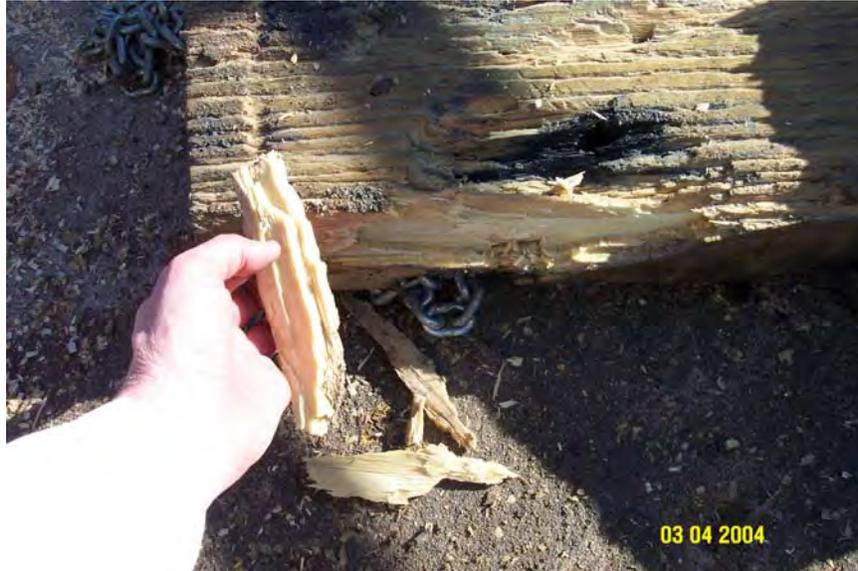
Detailed Landside Investigation of the Low Battery Seawall
Station 9+73 (84 Murray Boulevard)
The deck timbers appeared well preserved. However, the wood
fibers were very saturated with water and seemed “spongy”.

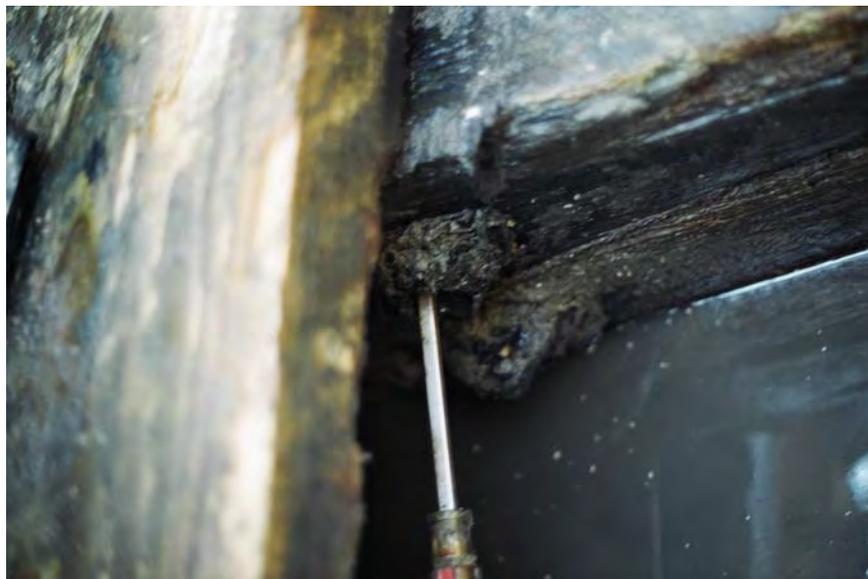
Detailed Landside Investigation of the Low Battery Seawall
Station 9+73 (84 Murray Boulevard)
The deck timbers appeared well preserved. However, the wood fibers were very saturated with water and seemed “spongy”.

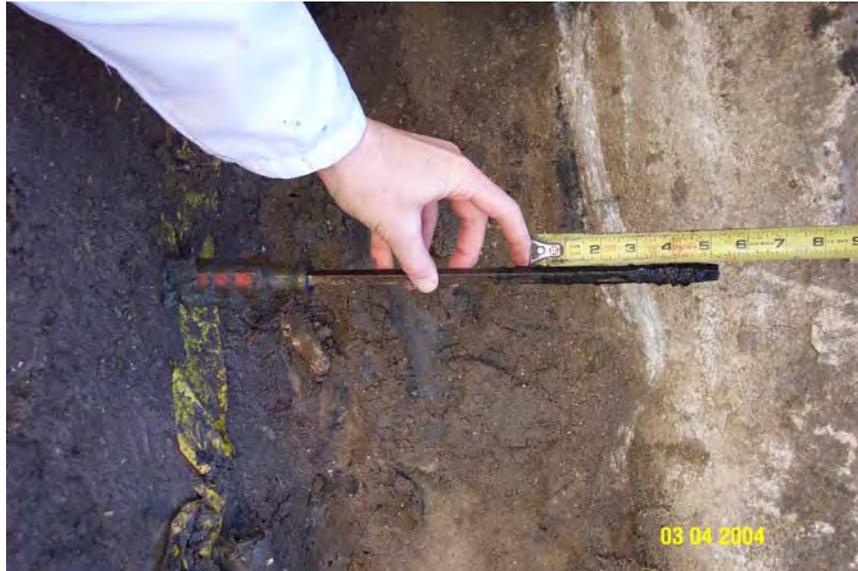
Detailed Landside Investigation of the Low Battery Seawall
Station 9+73 (84 Murray Boulevard)
The bolts were very severely corroded from the ends with significant loss of metal cross section. A screwdriver shaft could be inserted into the ends of the bolts and pushed several inches into the interior length of the bolts.

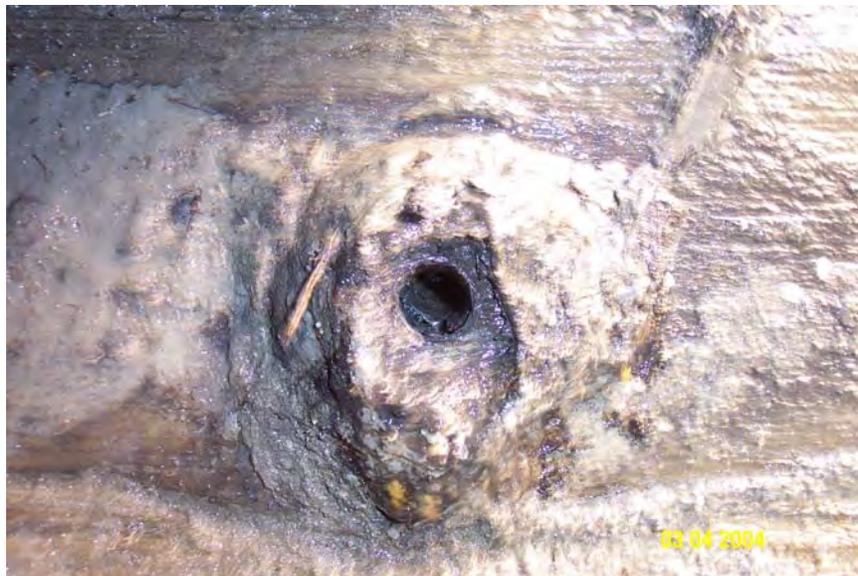
A screwdriver shaft could be inserted into the ends of the bolts and pushed several inches into the interior length of the bolts.

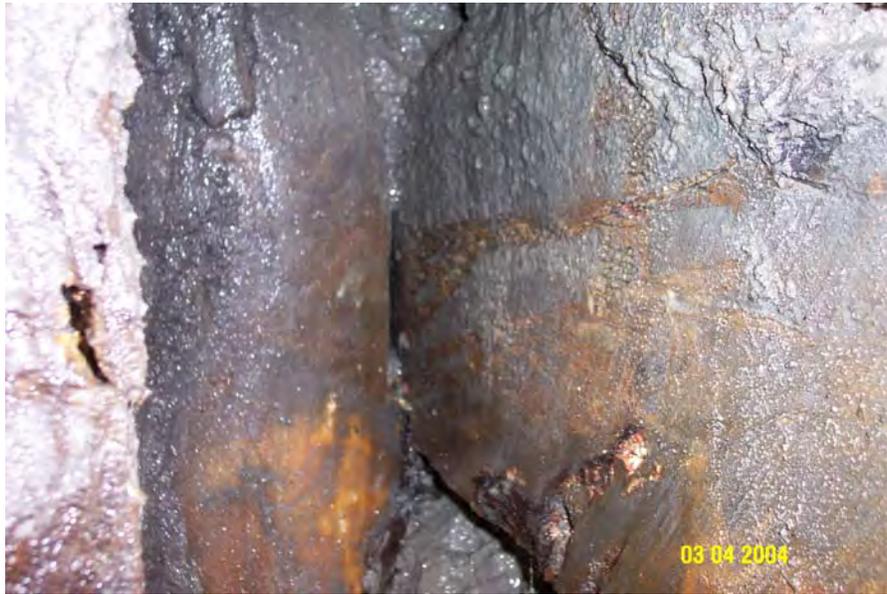
The bolts were very severely corroded from the ends with significant loss of metal cross section. The remaining cross-section of a bolt was more comparable to a thin walled pipe than a to a solid round rod.

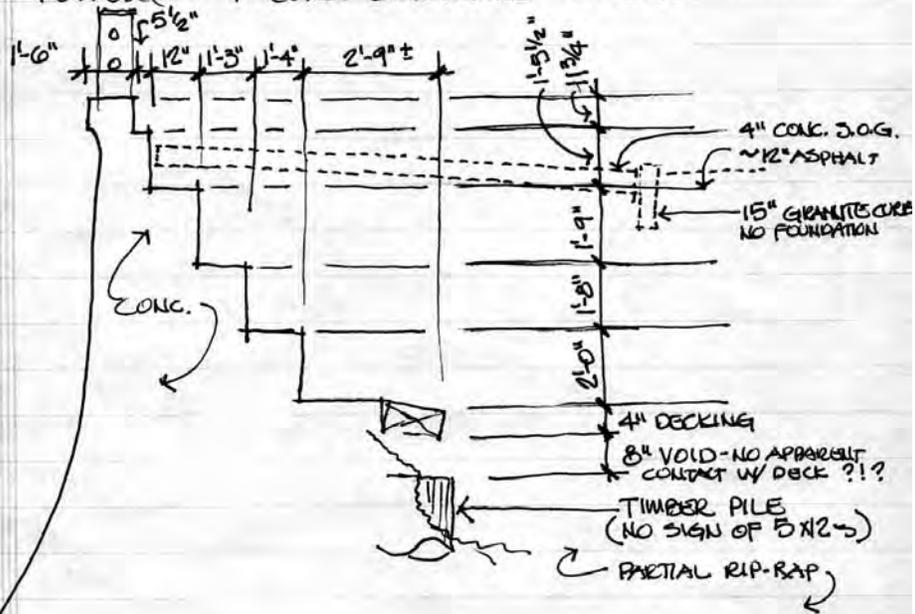
A pair of 5" wide x 12" deep timbers was bolted into the sides of the pile. The investigation revealed that approximately two inch wide by twelve inch deep notches had been cut into the sides of the piles to provide partial end support for the 5" wide x 12" deep timbers . At present, the ends of the 5" x 12" timbers are primarily supported by the notches cut into the sides of the support piles.

At best, the remnants of the bolted joint provided some nominal amount of rotational resistance for the connection.

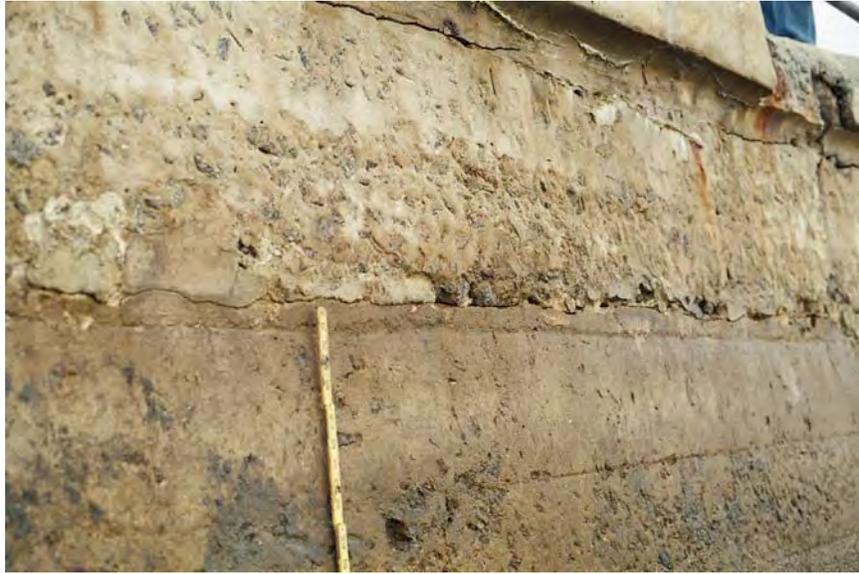
Detailed Seaside Investigation of the Low Battery Seawall
Station 27+48 (32 Murray Boulevard)
Signs of deterioration include rust streaks from exposed and corroding steel
reinforcing bars in the coping and horizontal cracks below the coping.

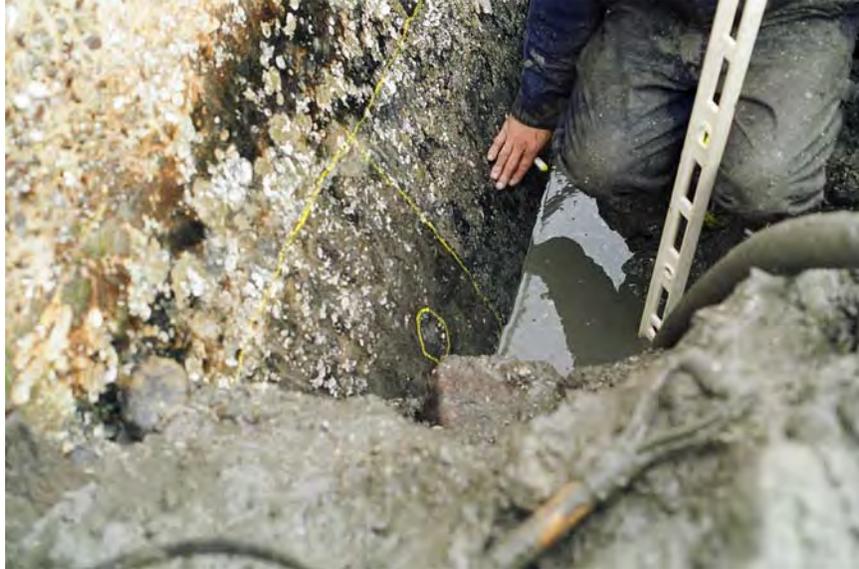
Detailed Seaside Investigation of the Low Battery Seawall
Station 27+48 (32 Murray Boulevard)
The vertical yellow line highlights the joint between adjacent concrete veil panels. The horizontal yellow line highlights the joint between the bottom of the seawall and the protective concrete veil. The concrete quality was very good and the joint between the bottom of the seawall and the protective concrete veil appeared sound.

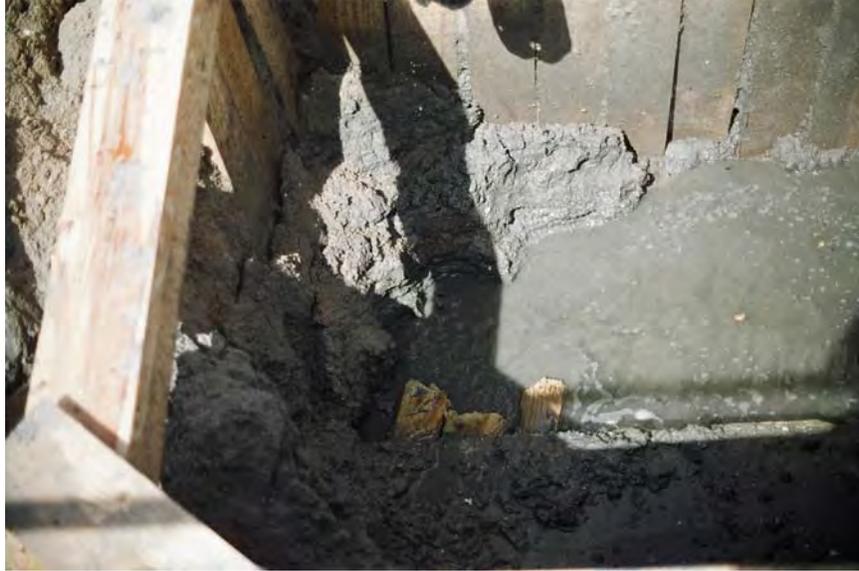
Detailed Seaside Investigation of the Low Battery Seawall
Station 27+48 (32 Murray Boulevard)
A core sample of the underlying timber sheet pile structure was taken.
The wood was in very good condition.

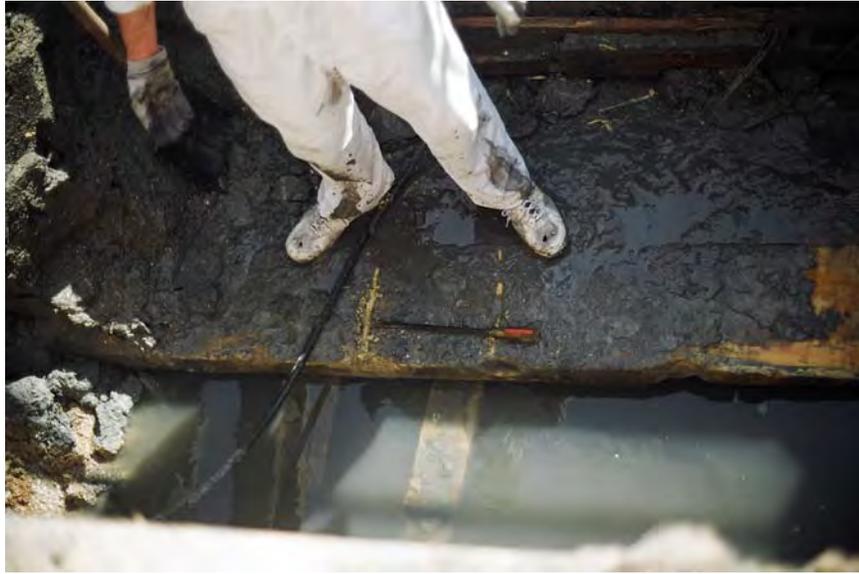
The platform deck timbers, the 5" x 12" timber beams, and the top portions of the piles appeared well preserved. Again, the wood fibers were very saturated with water and seemed "spongy"

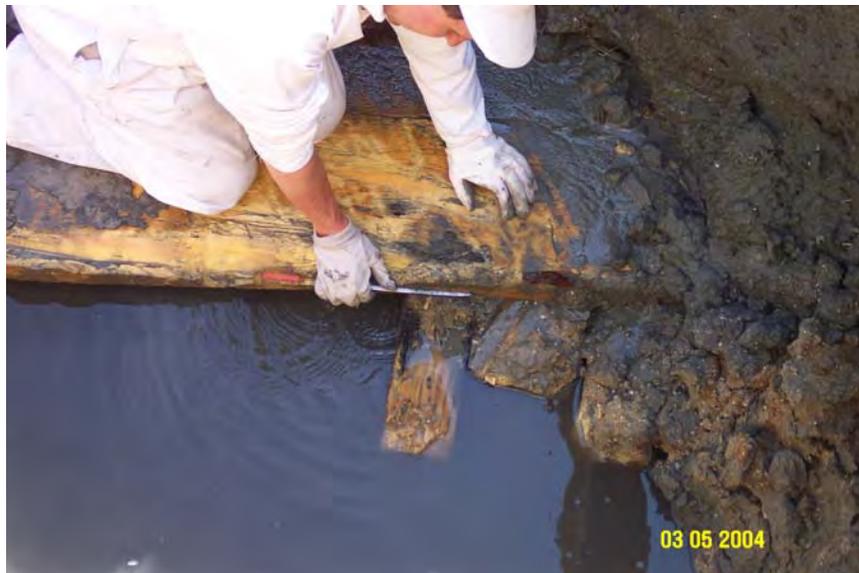
The bolts, washers, and nuts used in the connection of the 5" x 12" timbers to the piles again were severely corroded. A screwdriver shaft was pushed in its full 12 inches into the interior length of one bolt.

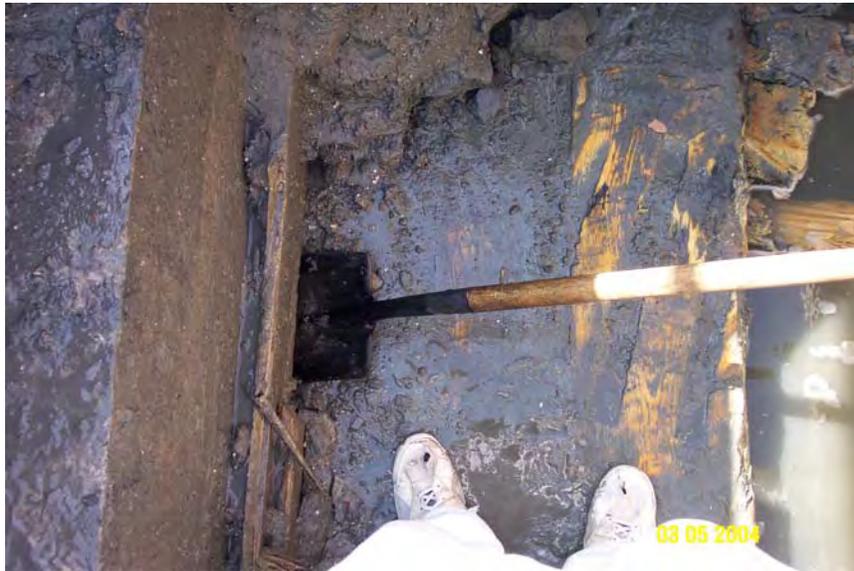
The bolts, washers, and nuts used in the connection of the 5" x 12" timbers to the piles again were severely corroded. A screwdriver shaft was pushed six inches into the interior length of another bolt before any resistance could be felt.

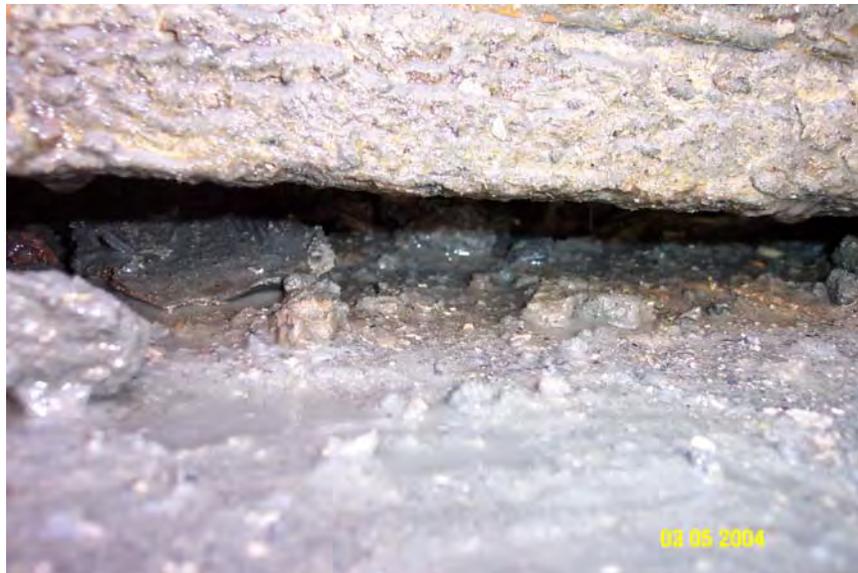
Detailed Landside Investigation of the Low Battery Seawall
Station 27+48 (32 Murray Boulevard)
At the landside of the seawall, approximately midway between supporting piles, there was an approximately one inch gap between the underside of the concrete seawall and the timber support platform.

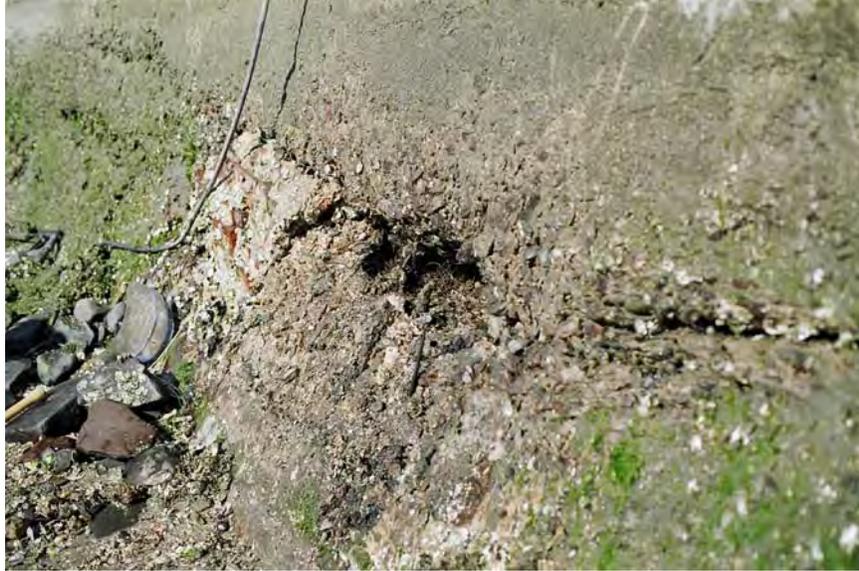
Detailed Landside Investigation of the Low Battery Seawall
Station 27+48 (32 Murray Boulevard)
At the landside of the seawall, approximately midway between supporting piles, there was an approximately one inch gap between the underside of the concrete seawall and the timber support platform.

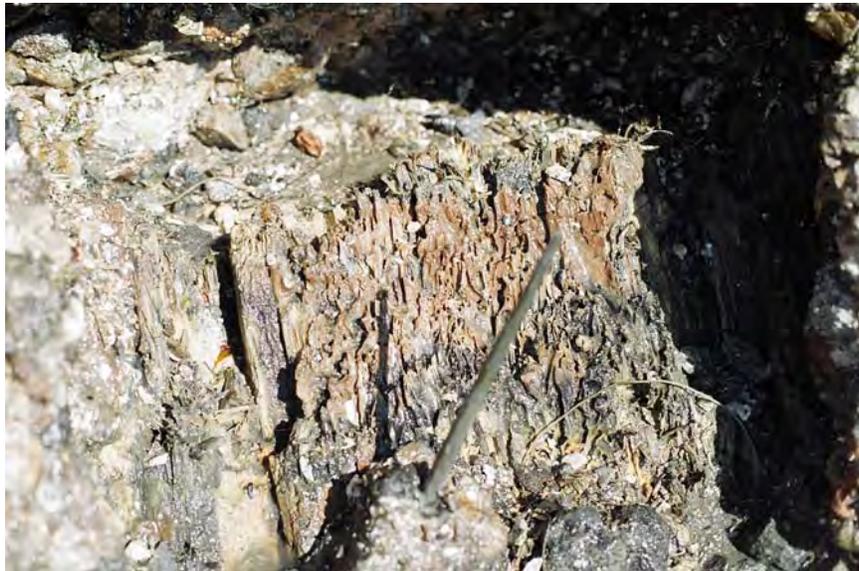
In this location, the timber sheet pile system extended approximately one foot above the timber platform and the protective concrete veil. The portions of the timber sheet pile system extending above the mud line were actively invested with marine boring organisms.

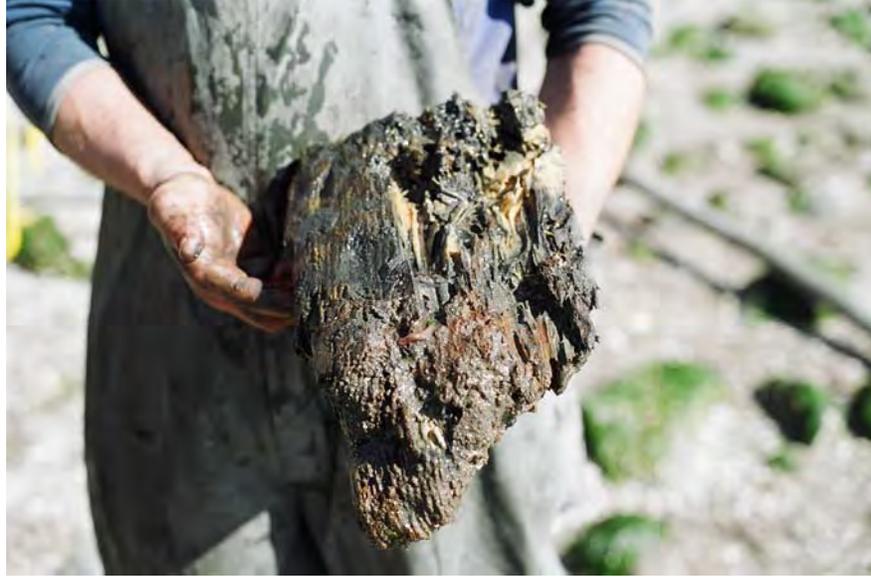
The portions of the timber sheet pile system extending above the mud line were actively invested with marine boring organisms.

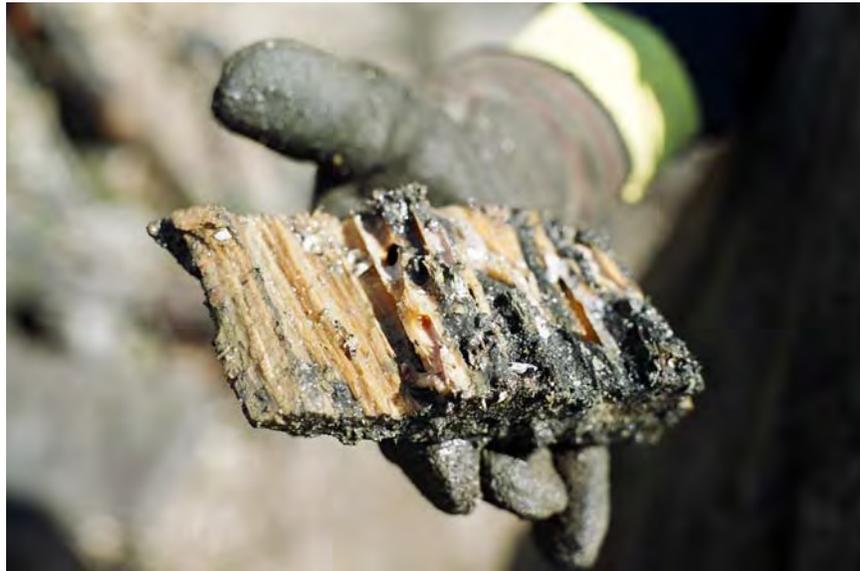
Detailed Seaside Investigation of the Low Battery Seawall
Station 43+50 (near White Point Garden)
A section of the timber sheet pile system extending above the mud line was removed. The timber was actively invested with marine boring organisms.

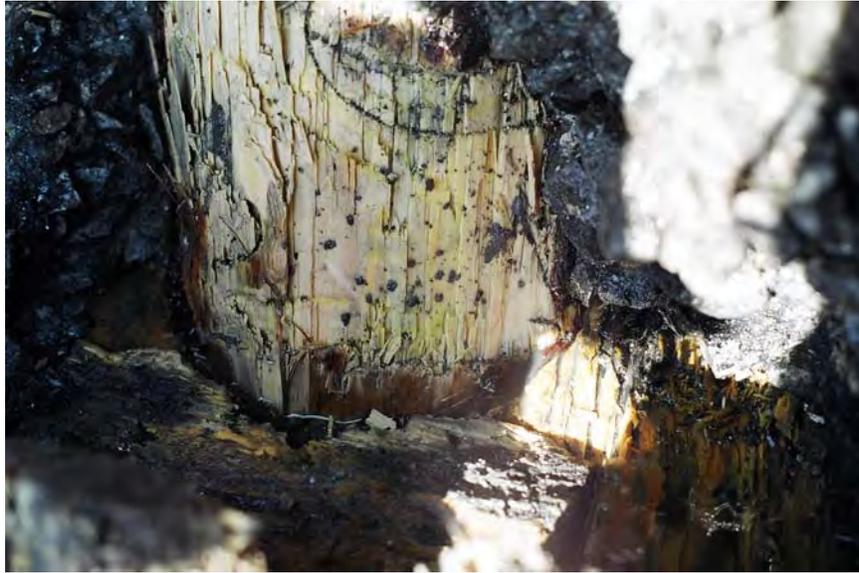
Detailed Seaside Investigation of the Low Battery Seawall
Station 43+50 (near White Point Garden)
A section of the timber sheet pile system extending above the mud line was removed. Note the marine boring organism tunnels and the resultant loss of timber cross section.

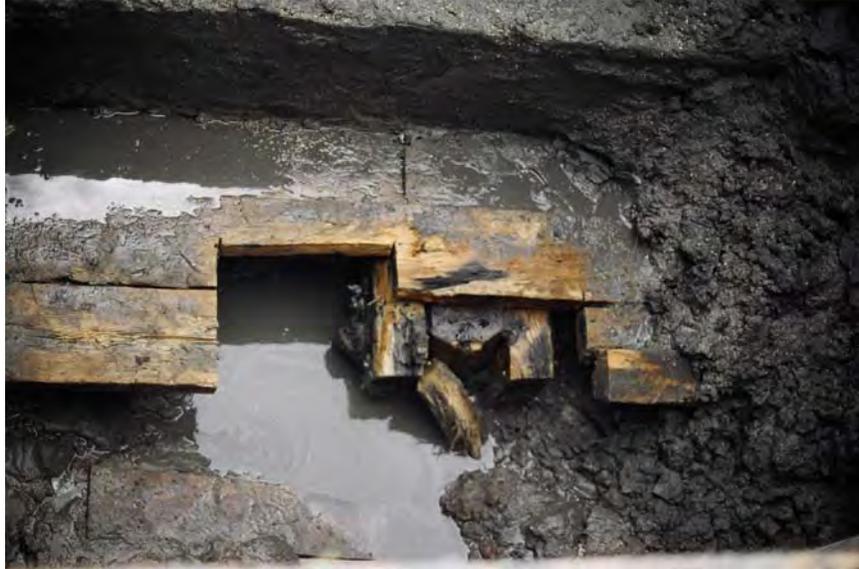
Detailed Landside Investigation of the Low Battery Seawall
Station 43+50 (near White Point Garden)
“The Boulevard Extension” also appears to have been constructed to the
dimensions and configuration presented in the archival design
sketch on page 1 of Appendix F.

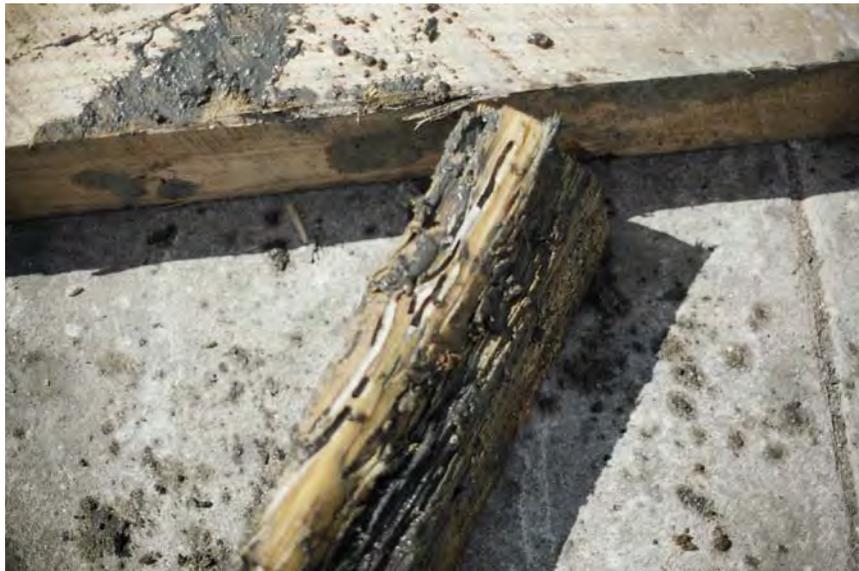
The landside excavation exposed the timber support platform and the top portion of a vertical support pile connected to a pair of 5" wide x 12" deep timber beams.

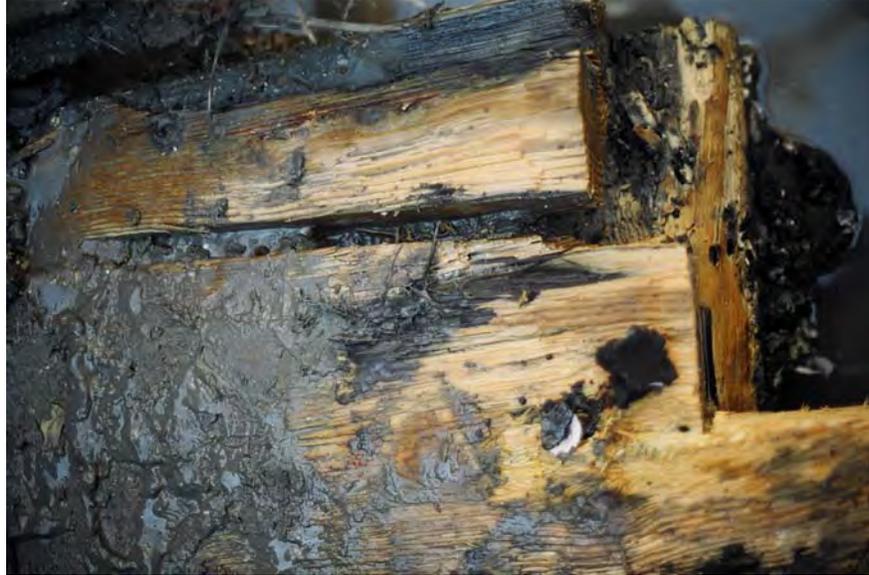
The underside of the timber platform had considerable marine borer damage believed to have occurred during the original construction phase when the platform extended over then-open water.

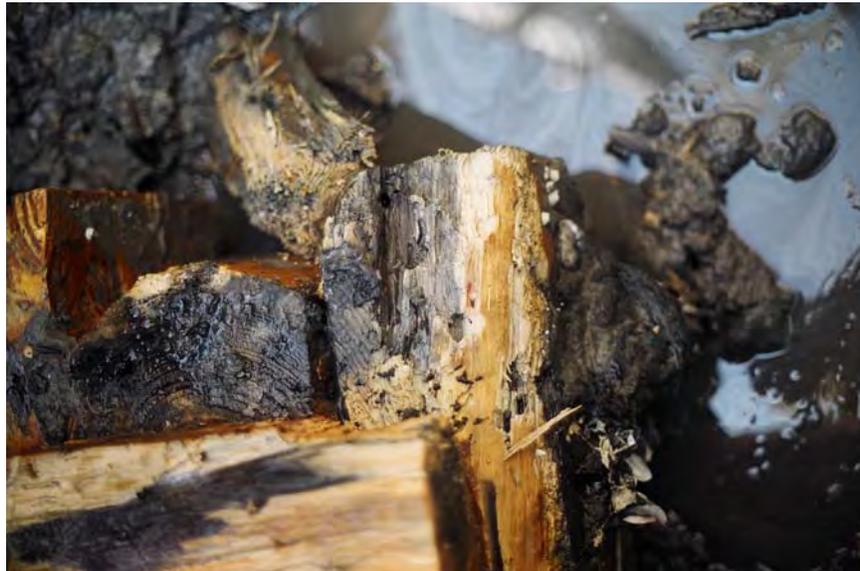
Detailed Landside Investigation of the Low Battery Seawall
Station 43+50 (near White Point Garden)
It was noted that the topside of the timber platform did not have any marine
borer damage.

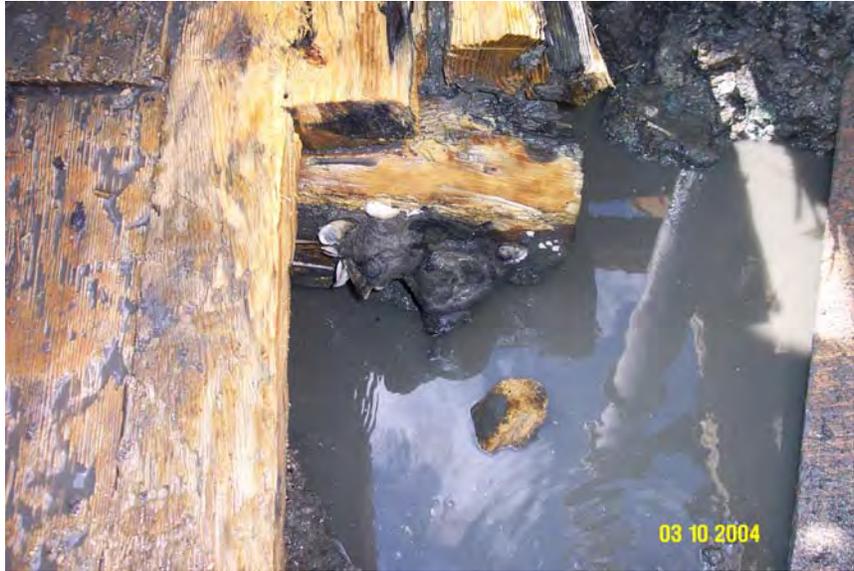
Detailed Landside Investigation of the Low Battery Seawall
Station 43+50 (near White Point Garden)
Again, the 5" x 12" timber beams and the top portion of the pile were saturated
with water and seemed "spongy". The spongy fibers extended approximately
an inch inward from the faces of the timbers before solid resistance could be felt.

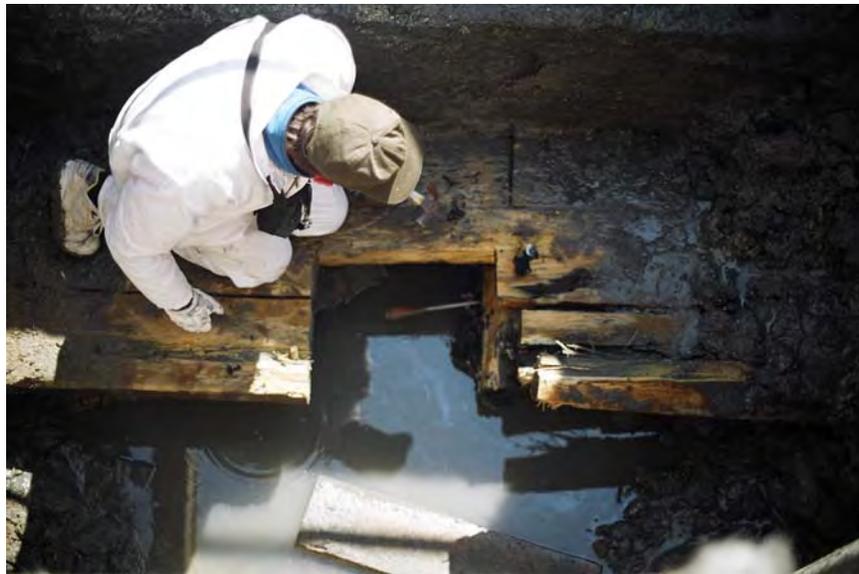
Detailed Landside Investigation of the Low Battery Seawall
Station 43+50 (near White Point Garden)
Similar to the other landside investigations, the steel bolts, nuts, and washers used in the connection of the 5" x 12" timber framing to the support piles were severely corroded. The ends of the bolted connections were heavily encrusted by a ferrous compound.
