5.0 Concept Design

5.1 General Improvements

Charleston Low Battery Investigation
866530, Charleston, SC
NOAA's Regional Rate: 0.00066 feet/yr
All values are expressed in feet relative to NAVD88

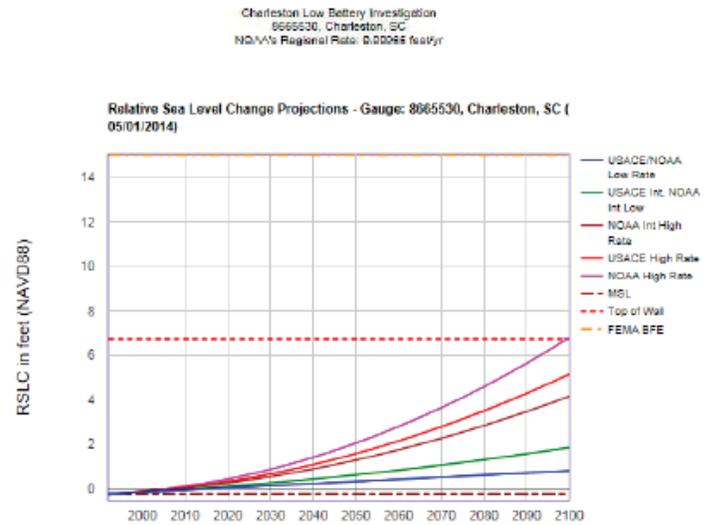
The graph above shows the Federal Emergency Management Agency (FEMA) based Base Flood Elevation (BFE) in an orange horizontal dashed line, obtained from Flood Maps for the area. The horizontal dashed red line represents the approximate top of existing seawall, while the three curves are alternative predictions, high, intermediate and low. The blue line, the low curve, represents the historic rate of sea level change. The green line is the intermediate curve and is a theoretical prediction that is developed using projections from the National Research Council and USACE calculations. The solid red line, or high curve, is again a theoretical prediction considering extreme events, such as the rapid loss of ice from Antarctica and Greenland.

The city of Charleston has set a sea level rise level at 2.5' in 50 years for planning purposes. Using the baseline of sea level rise, would raise the mean higher high water to 6.1' NGVD29 which is 1.6 feet below the top of wall. And the highest atmospheric tide at 7.60' which is right at the top of the wall. Based on this, an increase in the top elevation of wall should be considered.

Aside from sea level rise, consideration should be given for raising the wall a modest height to protect against overtopping during storm events such as seen during the 1,000 year storm of October, 2015. Since overtopping of the wall was frequently noted during this unprecedented event, an increase of at least 1 foot is reasonable to aid in defending against future storms and this will be further investigated during final design.

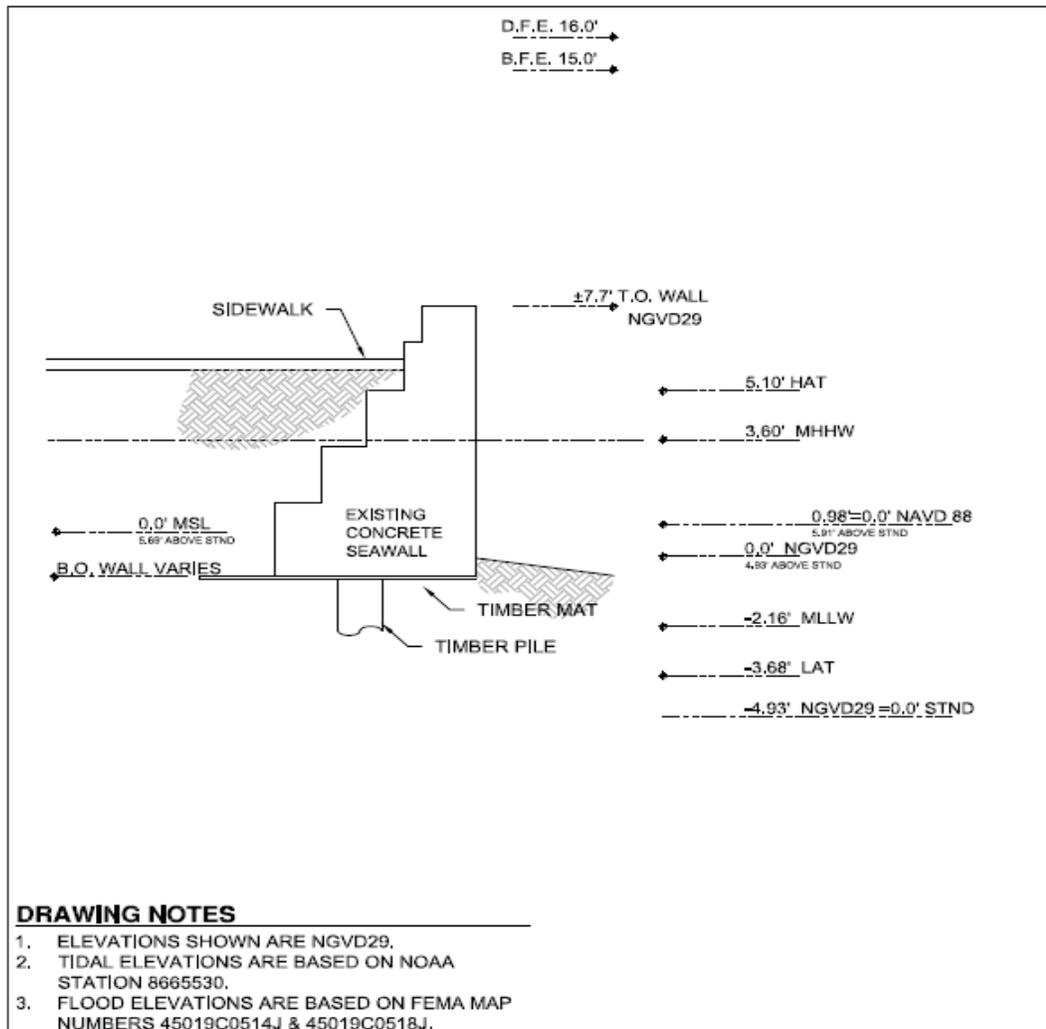
It is important to note that the purpose of the low battery seawall is not to prevent overtopping during a storm event. As shown below the FEMA predicted base flood elevation (BFE) greatly exceeds the height of the wall. The wall is to prevent the normal water levels from overtopping.

The sketch above shows the existing sea level conditions of the seawall at the Low Battery.

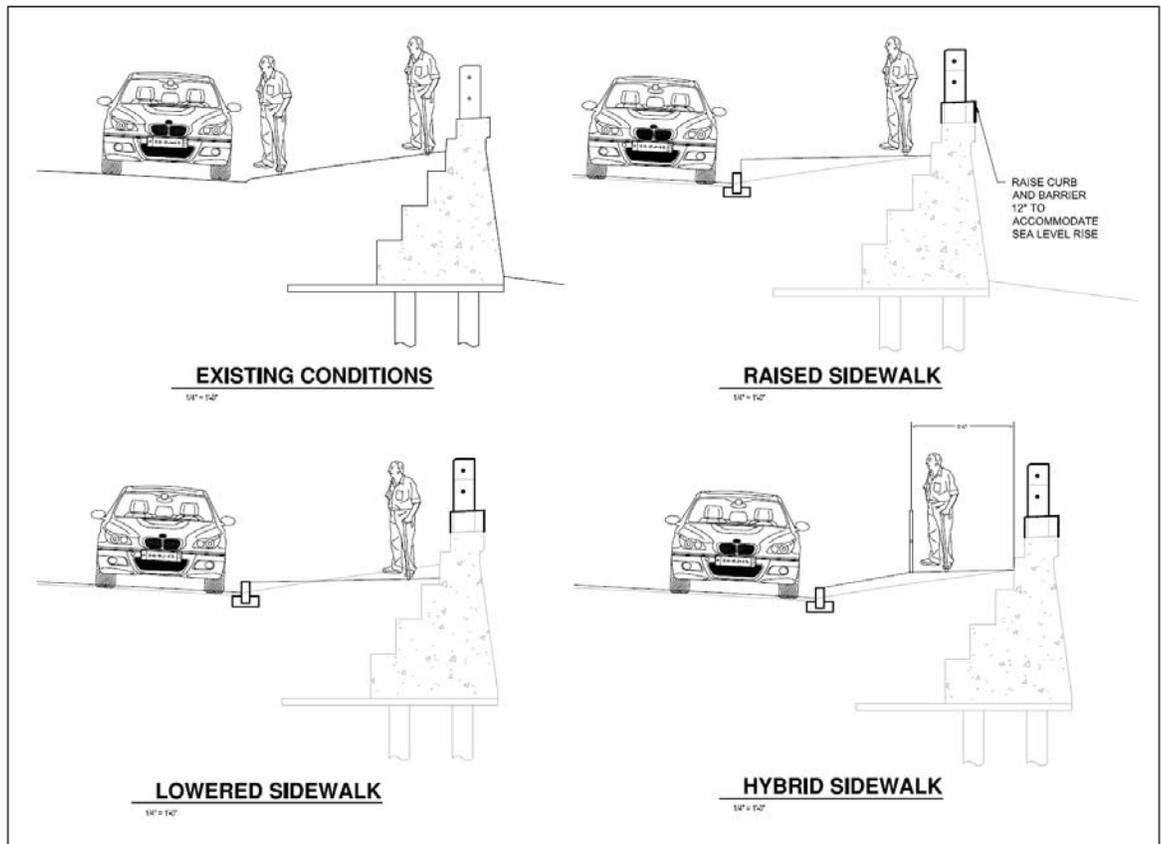
Sidewalk and curb options

Portions of the existing sidewalk were in compliance, however there was a considerable length that was non-conforming. Any work in this area should bring the sidewalk up to the minimum required conditions (2% max. cross slope & 5% max. running slope). The three feasible options for this predicament are as follows:

- Option one: lower the sidewalk. Starting at the street level, establish the 8" curb height and add the conforming slope upward until the curb and barrier at the face of the seawall is reached. This will necessitate a much higher curb, in order to maintain the top of seawall elevation. In the worst case the curb height would be approximately 2'-6" above the sidewalk surface.
- Option two: Raise the sidewalk on the street side however this option would create an obstruction for car doors and impair the parking lane. This option would also require a barrier rail on the landward side of the walkway, increasing installed cost.
- Option three: A hybrid, maintain a minimum walkway width of 36" and then slope down to the curb with a concrete or other impervious surface. This option would also require a barrier rail on the landward side of the walkway, increasing cost and maintenance.

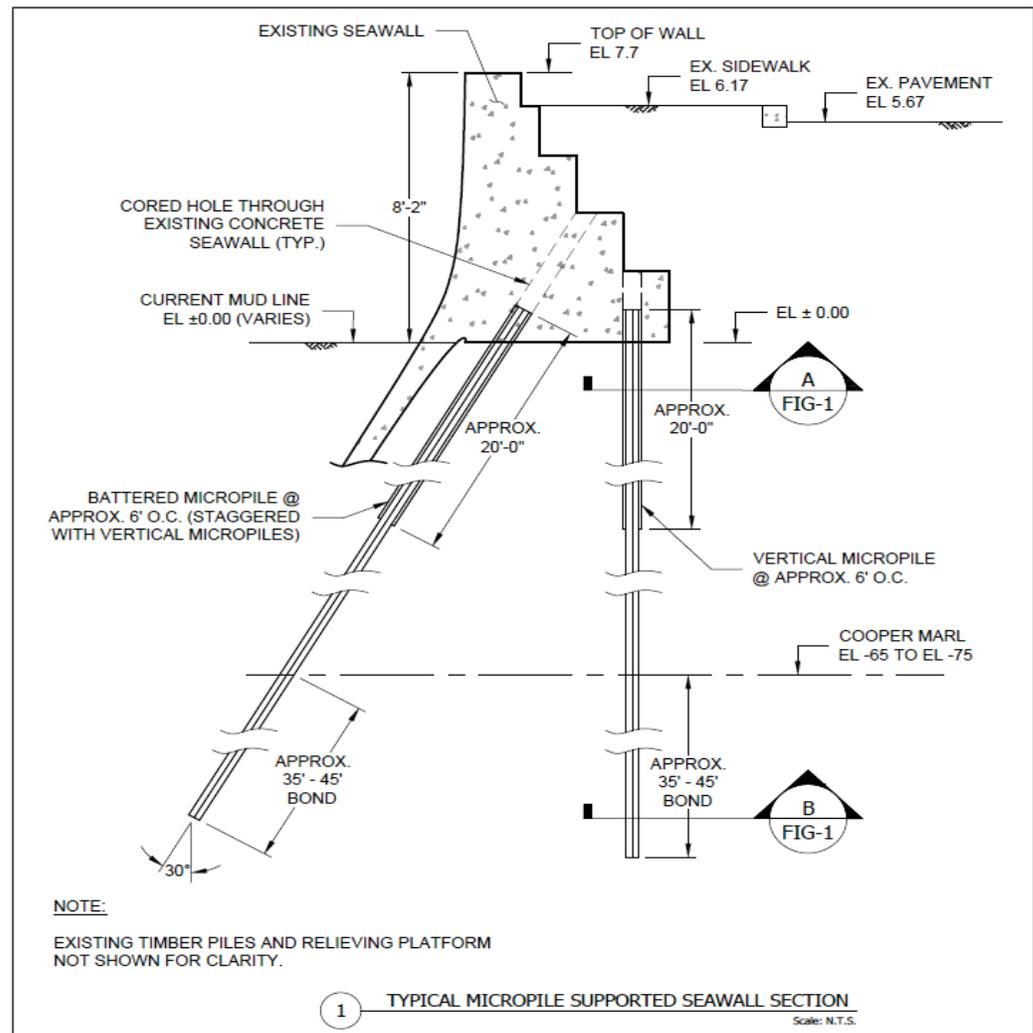
Figure 1

Option 1 (shown in Figure 1) utilizes pairs of vertical and battered micropiles to relieve the load on the existing timber piles. The battered piles would provide increased lateral load capacity to support the flood and saturated soil loading on the seawall. In the critical flood condition the battered micropiles would act in tension and the vertical micropiles would act in compression. The center bar would provide axial capacity to the micropiles and the bond zone would transfer the axial load into the stiff cooper marl. In one version of this option, the top of the micropiles would be integrated into the existing seawall and the load transferred to the piles through bond with the existing seawall once the core holes are grouted.

Option 1 assumes that the existing seawall concrete has adequate strength to transfer the loading into the piles. If further investigation indicates that the existing seawall concrete does not provide adequate strength to transfer the load, then Option 2 (shown in Figure 2) would be considered. The design of Option 2 is similar to Option 1 because it relies on the same layout of battered and vertical micropiles to support the lateral flood loads.

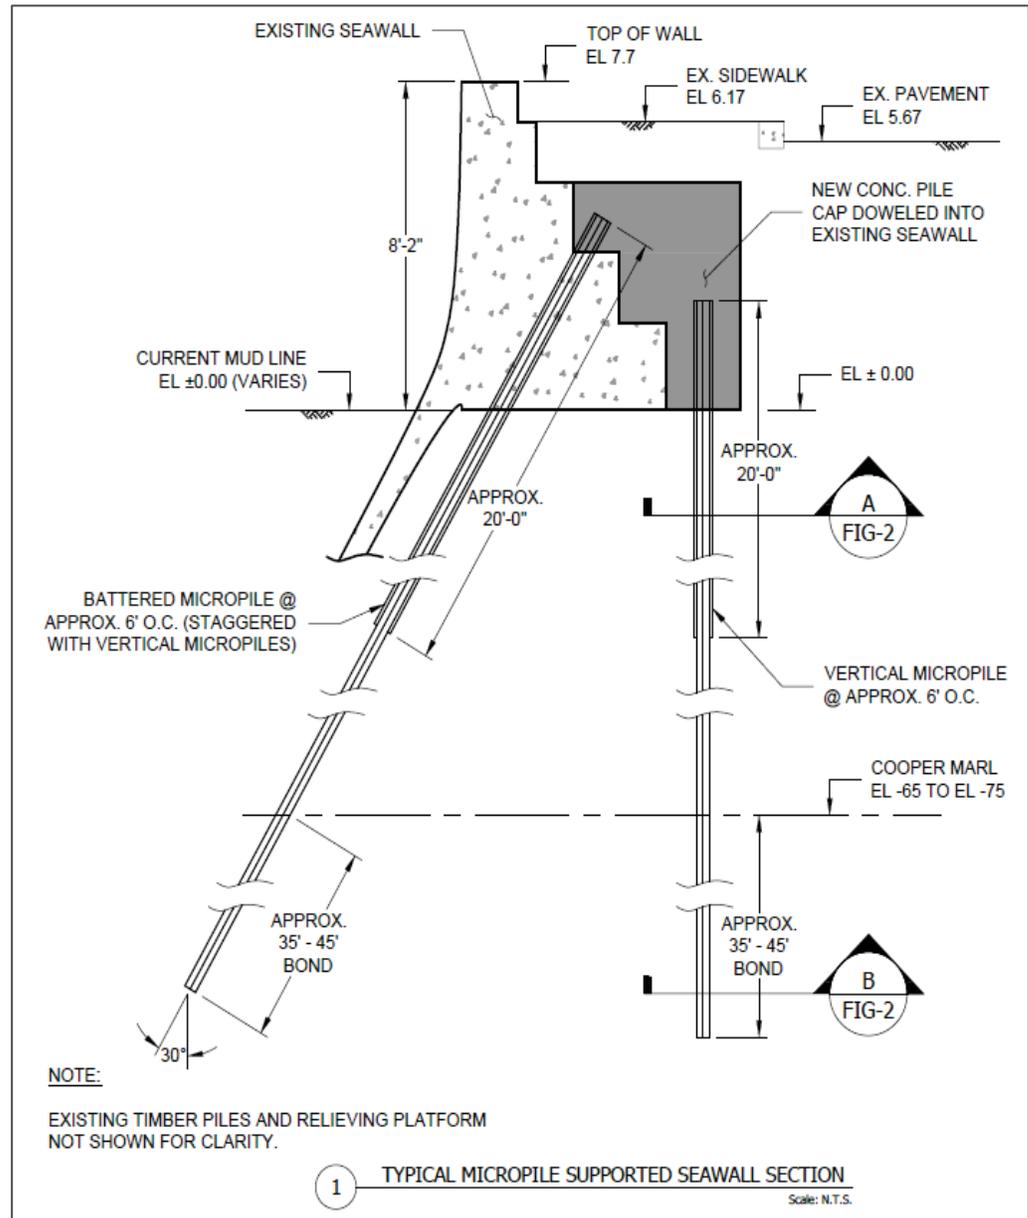
Figure 2

However, Option 2 would utilize a new concrete pile cap to transfer loading into the micropiles. This concrete pile cap would be bonded thru dowels into the existing seawall concrete and could reduce the amount of coring required during pile installation. Option 2 would also provide for additional settlement support of the sidewalk and reduced backfill thickness underneath the sidewalk.

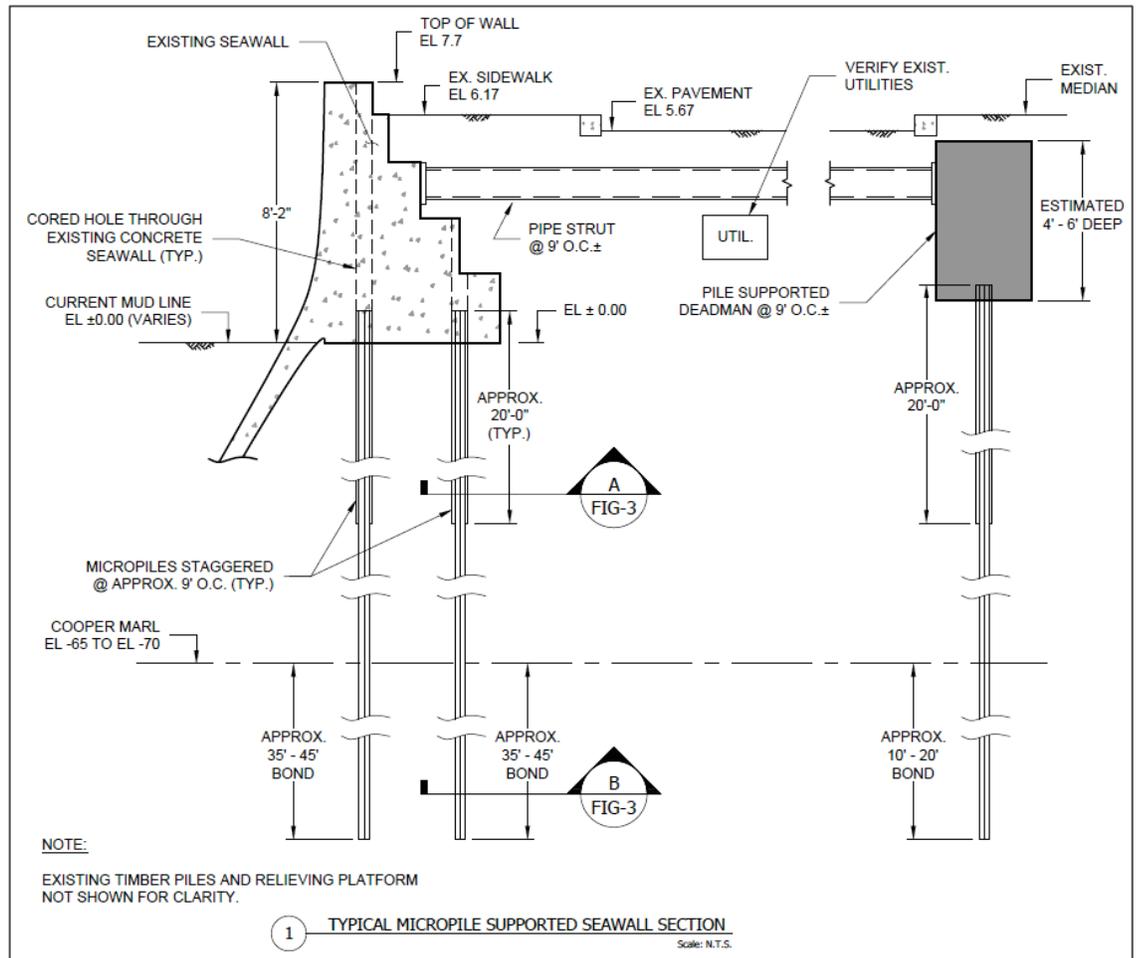
Figure 3

As an alternative to the battered micropile systems, Option 3 (shown in Figure 3) would utilize a pile-supported deadman to provide capacity to resist lateral loading. This option would transfer load from the seawall to the deadman through a pipe strut that would be installed below the road. The deadman would be constructed below the roadway median and would be supported laterally by passive earth pressure. Option 3 would eliminate the need for battered micropiles and would reduce the amount of required micropiles installed along the seawall. However, this option would increase the overall project limits of disturbance, limits of work, and required permanent easement below the roadway.

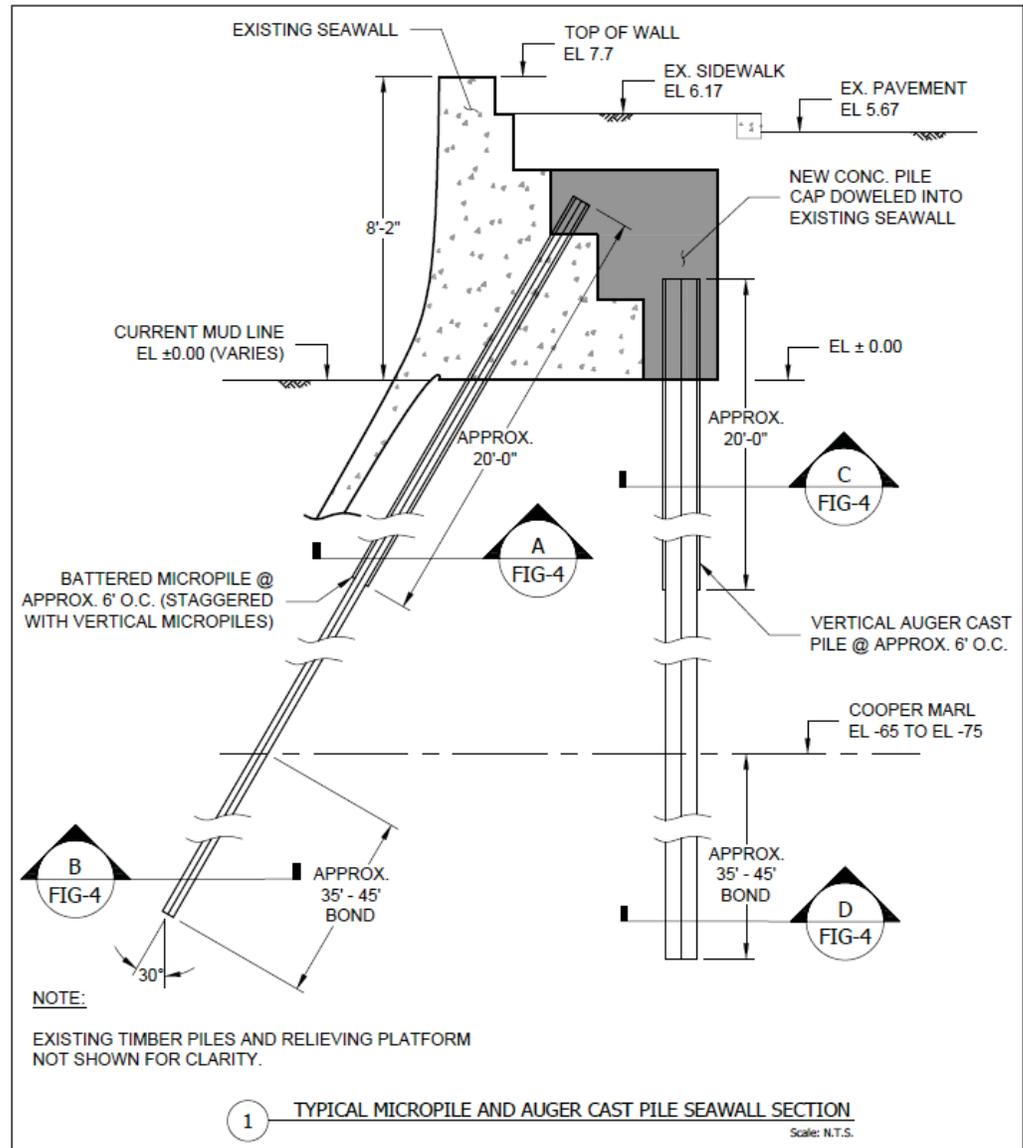
Figure 4

Option 4 (shown in Figure 4) is similar to Option 2, except that Option 4 would replace the vertical micropiles with auger cast piles. The use of continuous flight auger (CFA) piles in Option 4 could provide a simpler and less expensive alternative to the vertical micropiles specified in Options 1 and 2. However, mobilization of two different pile systems and the space requirements for installation of the CFA piles may have additional impacts to the project.

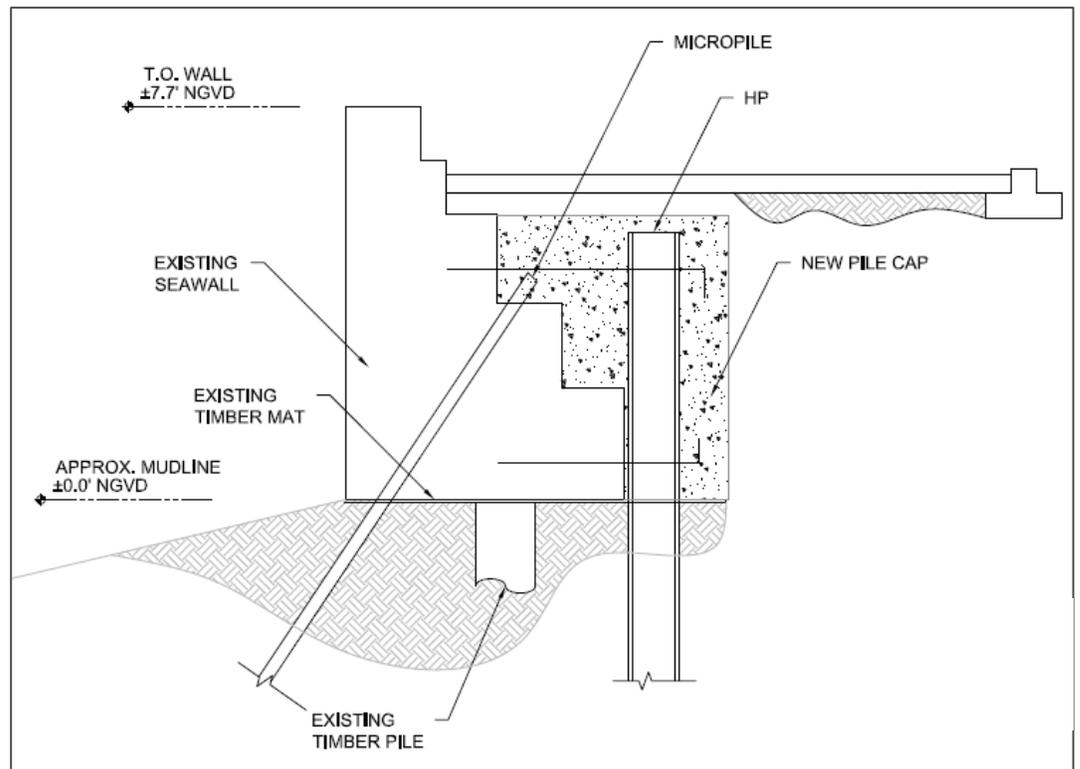
Figure 5

Option 5 (shown in Figure 5) is similar to Option 2, except that Option 5 would replace the vertical micropiles with steel "H" piles. The use of a conventional steel H-pile installed with a vibratory hammer could provide a simpler and less costly alternative to the vertical micropiles specified in Options 1 and 2. However, mobilization of two different pile systems and the space requirements for installation equipment necessary for the HP pile installation may have added impacts to the project. The driven pile option would likely have the largest impact on the nearby residences through vibration and noise vs. the more surgical drilled in micropiles or auger-cast piles.
