Appendix M

Detailed Seaside and Landside Investigation
of the Low Battery Seawall
Photographs, Field Notes, and Sketches

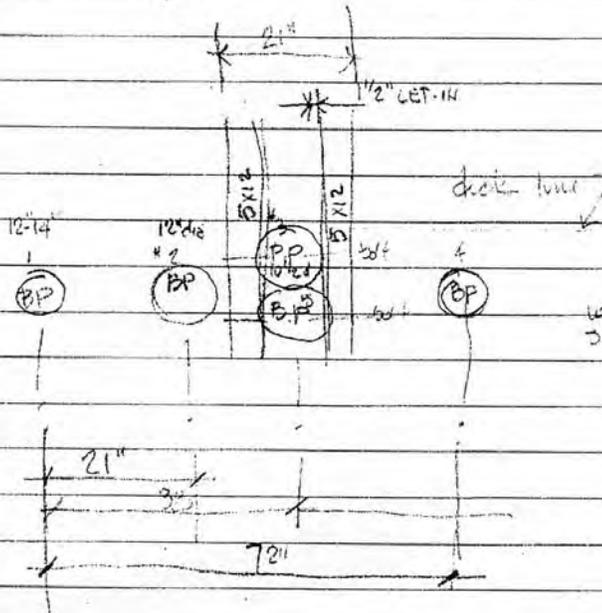
P.2/4

- exposed additional wood framing to view 5 piles, vertical and battered
- viewed 5x12 brackets, wood deck extremely soft below deck
- wood sheet piles ~~in tact~~ intact
took samples of wood sheet pile, pile hardware in good
- wood sheet piles are uniform, serious batter to slope
assembly
measured/sketches layouts etc.
- no further info needed this site
- ~~re back filled~~ w/ loose stone/rip rap.

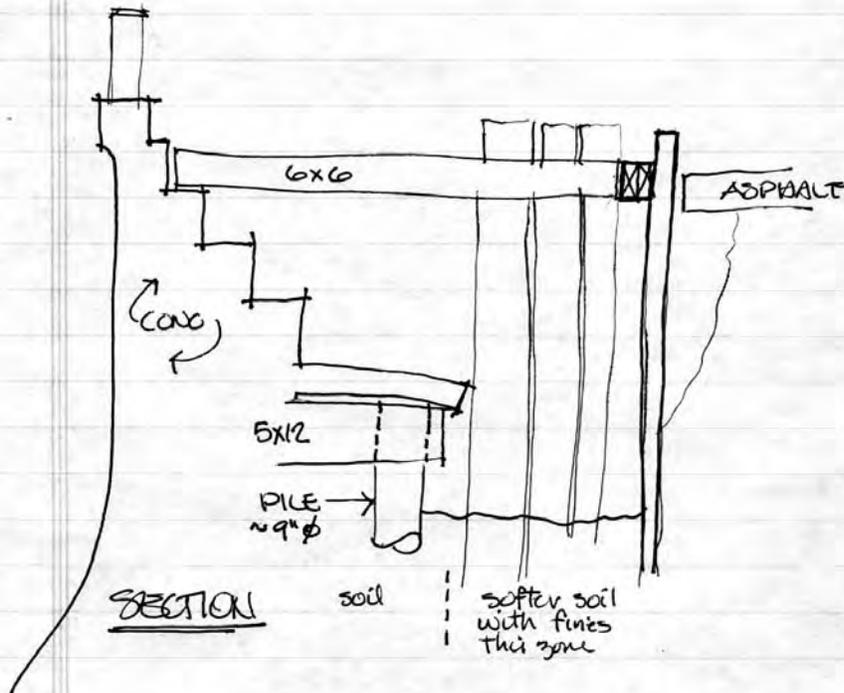
- City furnished equipment + personnel
backhoe, dump truck, voc truck, shoring (3x6, 6x6)
barrièades
- Reexcavated hole, expanded westward,
installed shoring along alphalt and
return ends

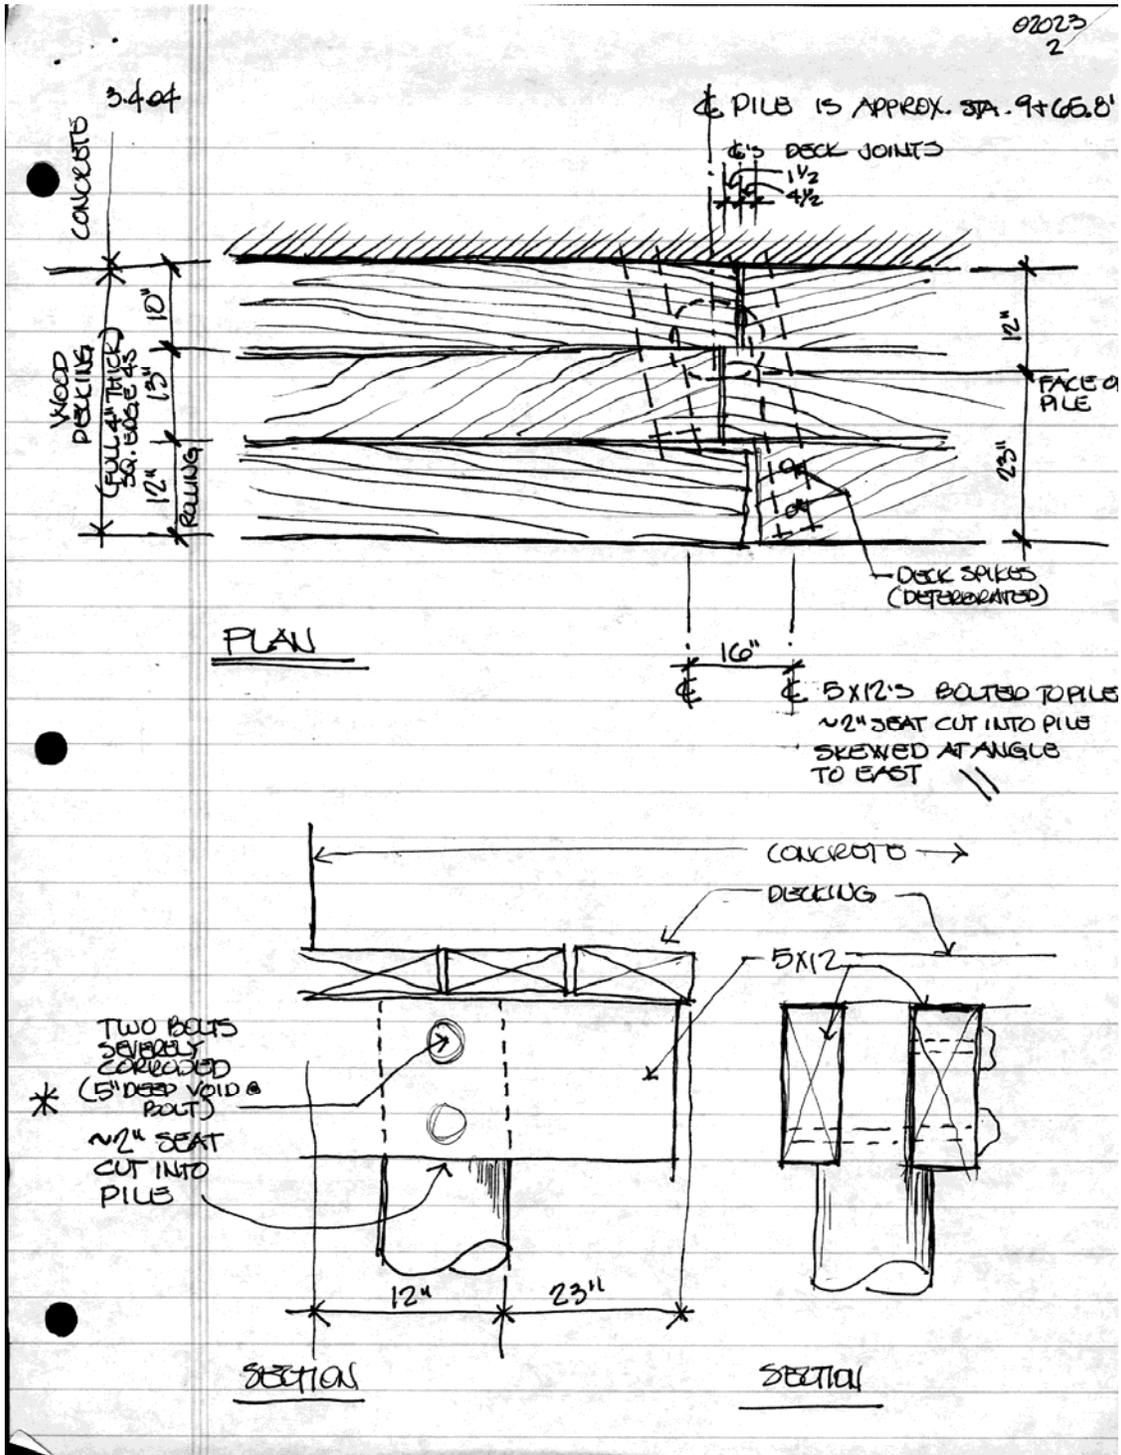
02023
3

- material between 5x12's coarse sand w/ little clay, ~ course wet beach sand generally tight to underside of decking
- 4" decking, generally well preserved, but spongy, compressible, no signs of worms underside of decking eroded, very 'cheesy' texture, flush at bearing surface (on 5x12) but very soft. Decking is cut 43
- 5x12's appear solid, but bolts severely corroded, washers appear conical - difficult to confirm - Note 5" deep void at bolt holding 5x12 to pile!
- pile ~ 12" ϕ timber, generally sound, although exterior spongy.

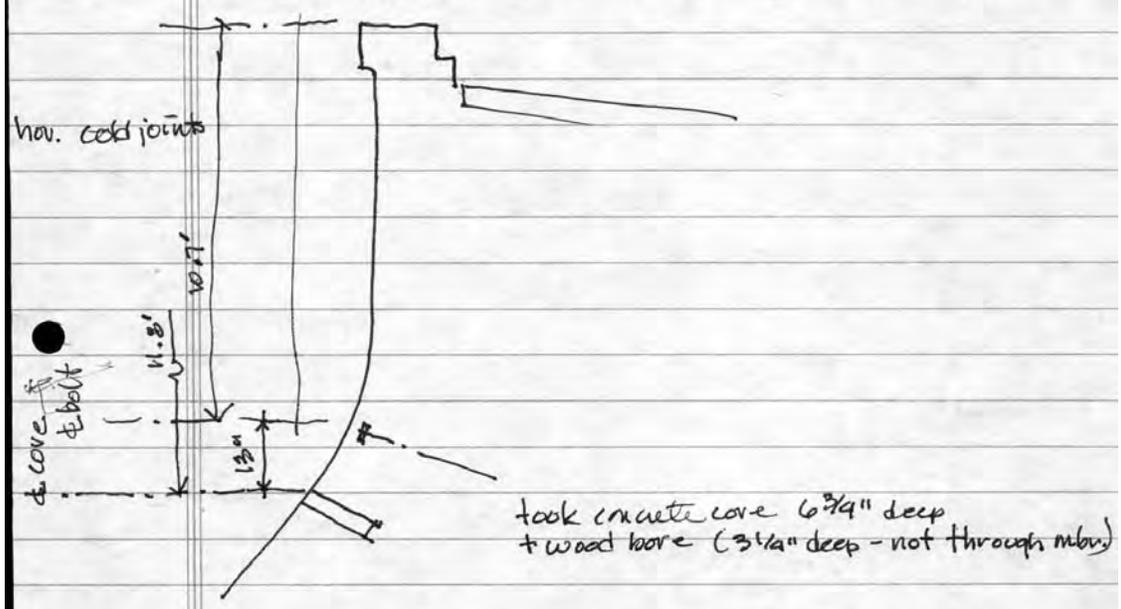
'control area' no snow face defects

- difficult to see vertical 'veil' joints (design is 4')
- found one bolt (patch over intact), bolt intact
- horizontal control

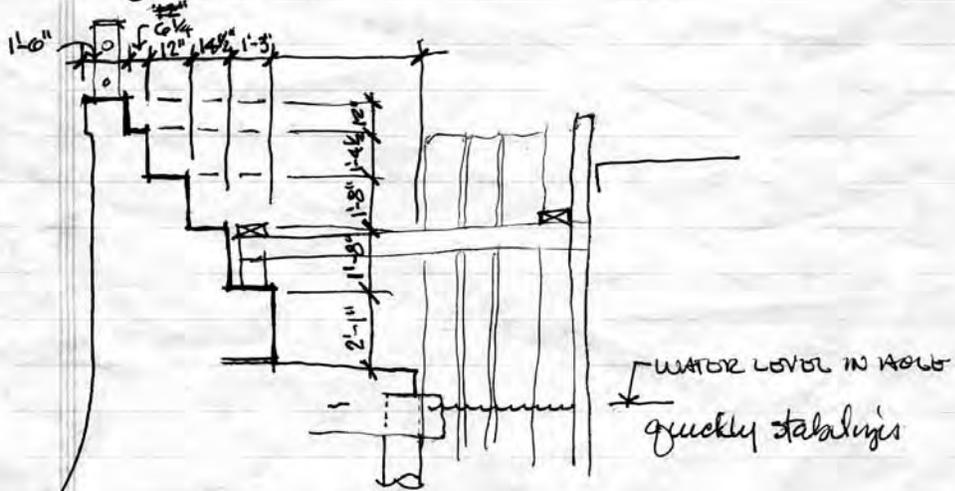
02023
2

- City ~~also~~ equipment + personnel (backhoe, dump truck, vac truck, wd. shoring)
City has installed [wood shoring and excavated defined site, removed sidewalk 4" slab and stone curb concrete seawall virtually same as first excavation, virtually same as archived section drawing,
- top ^{tan} sand, then clayey sand
- note water level stabilizes ~ 2'-4" below underside of wood decking very rapidly after Vac Truck lowers level.

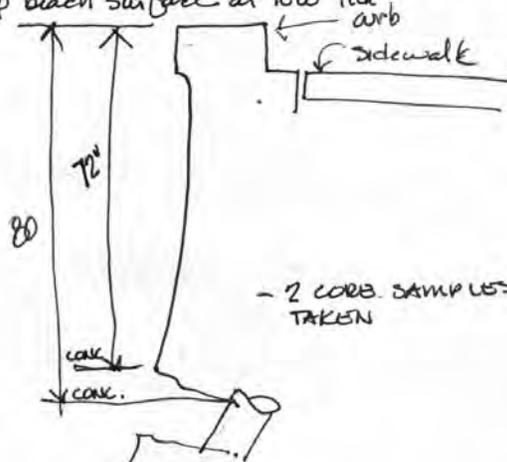
- station 43+50 (King + pt.)
- existing failed face
- adjacent area of concrete w/ brick patch, bulging
- aggregate generally uniform, ~ 2" sharp edged stone
- shell and rip rap beach surface at low tide

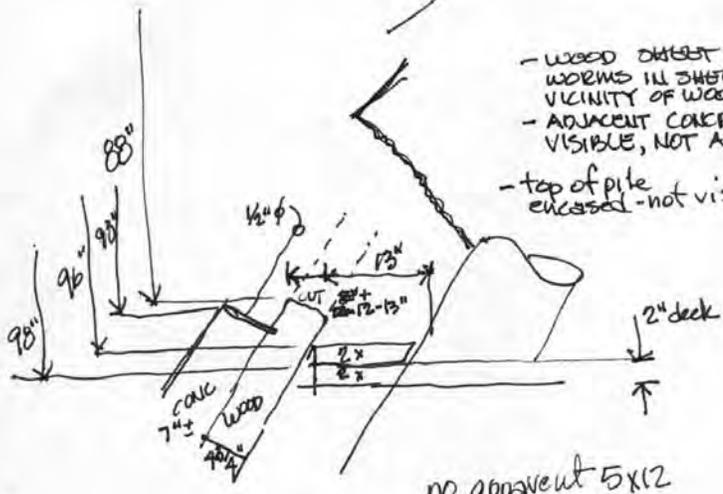
- wood sheet pile top visible, bloody worms in sheet piles and mud in vicinity of wood
- adjacent concrete sheet piles' tops visible, not at uniform elevation
- top of pile encased - not visible

no apparent 5x12 frame thru pile
