5.0 Concept Design

5.1 General Improvements

Charleston Low Battery Investigation
866530, Charleston, SC
NOAA's Regional Rate: 0.00066 feet/yr
All values are expressed in feet relative to NAVD88

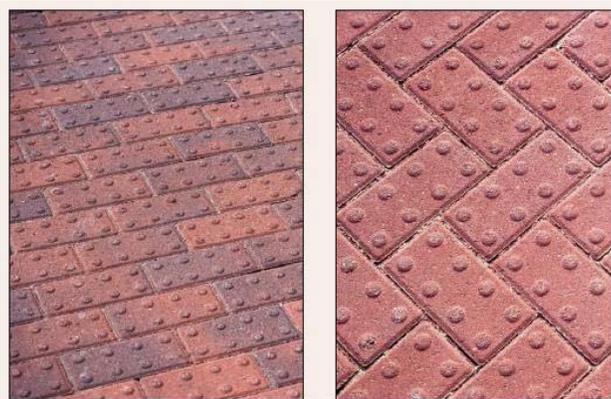
Portions of the existing sidewalk were in compliance, however there was a considerable length that was non-conforming. Any work in this area should bring the sidewalk up to the minimum required conditions (2% max. cross slope & 5% max. running slope). The three feasible options for this predicament are as follows:

Although not explicitly required by the ADA requirements, crosswalk lines shall be required at all crossings on SCDOT maintained roads. In

this case, all designated pedestrian crossing points along Murray Blvd. shall be marked with 8" solid white lines, not less than 6' apart.

Although not explicitly required in the current ADA Standards for Accessible Design, it is recommended that additional curb ramps and crosswalks be installed along Murray Blvd. at several of the intersections. It should also be noted that if these curb ramps and crosswalks are installed, compliance with the curb ramp on the other side of Murray Blvd. will also be needed.
